Challenges and Solutions for Air Tightening Multistory Homes; Addressing Breaches in Floor Cavity Air and Thermal Barriers

EEBA 2014 St. Louis, Mo
Day 1 Session - 10:30 AM-11:15 AM
September 23, 2014

Addressing Breaches in Floor Cavity Air and Thermal Barriers in Multi-Story Homes

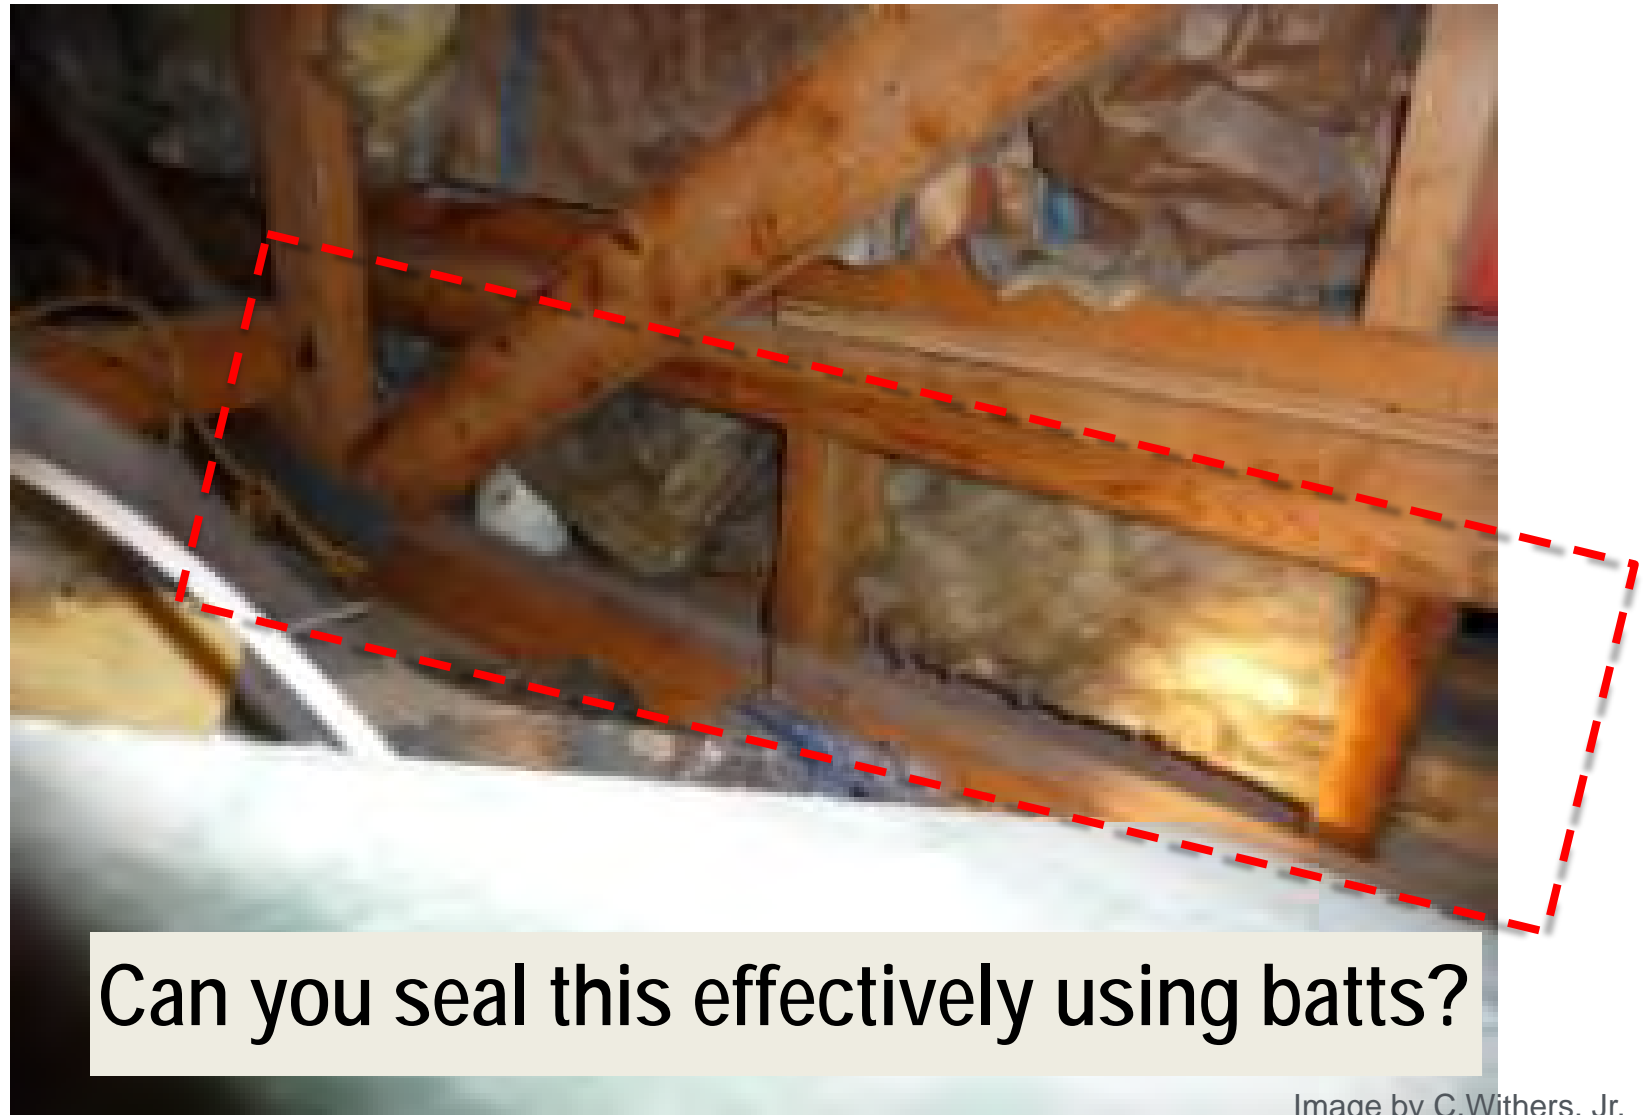
Poorly Installed Batts at Floor Cavity

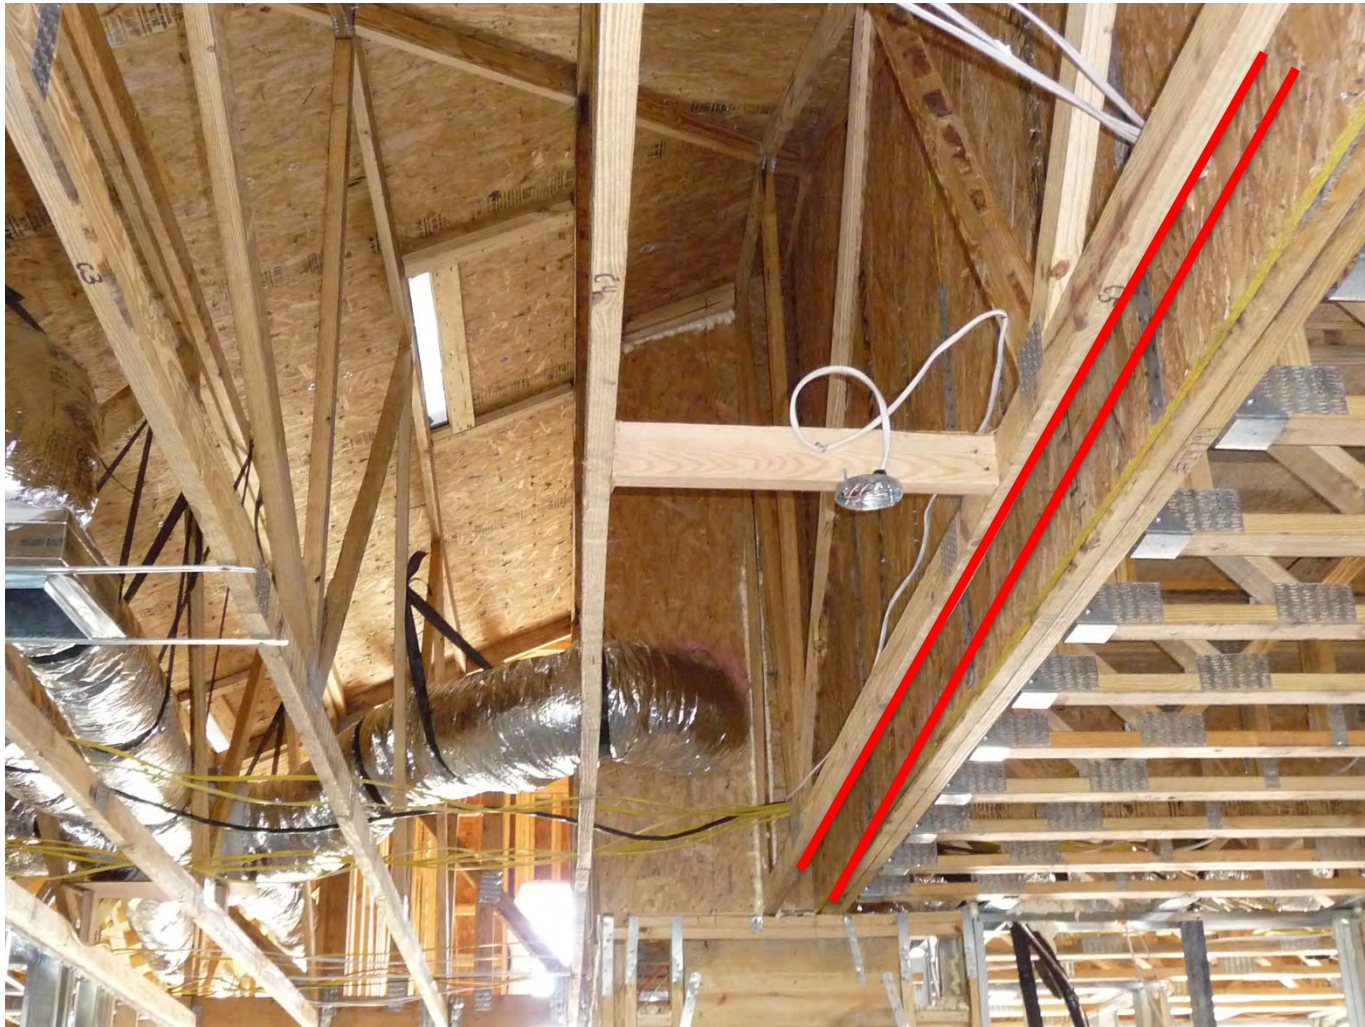
Floor Cavity is Sealed by Plywood, But Little Clearance Between Roof Truss and Kneewall.

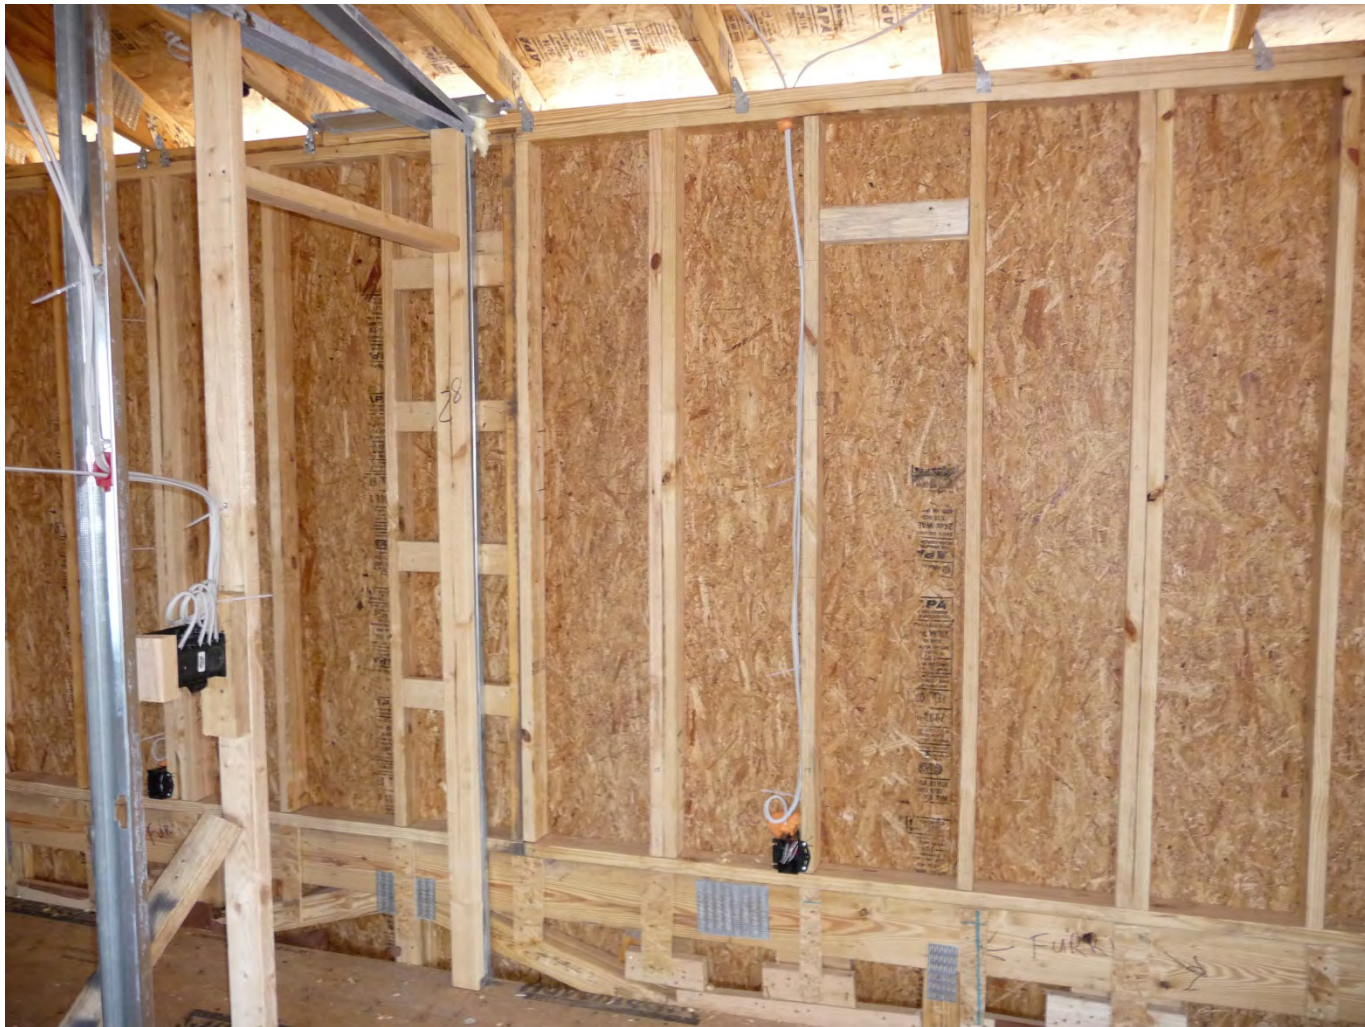
Interior of This Wall Is Not Good Location for Batts !

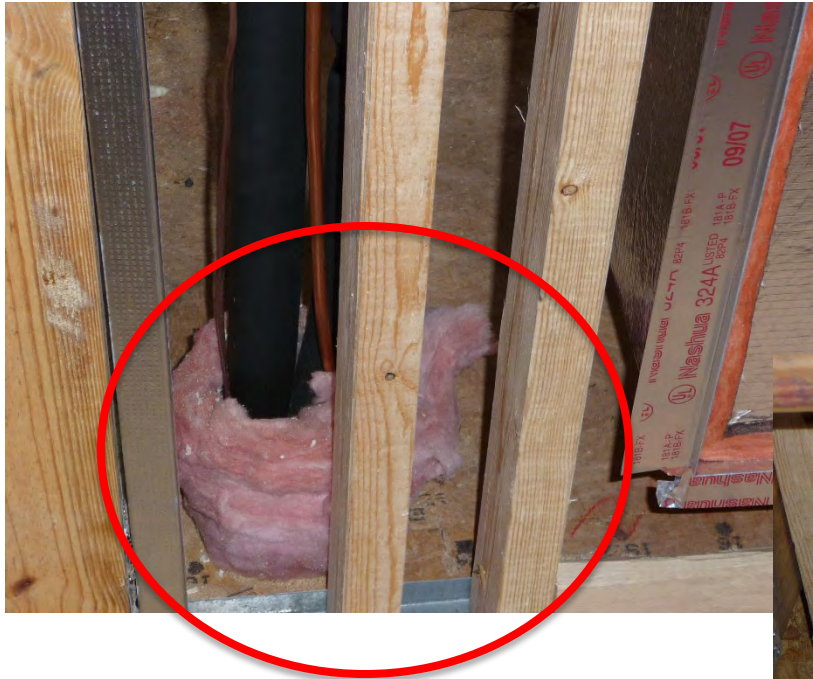
2nd Floor System Refrigerant Floor Cavity Penetrations Need to Be Sealed.

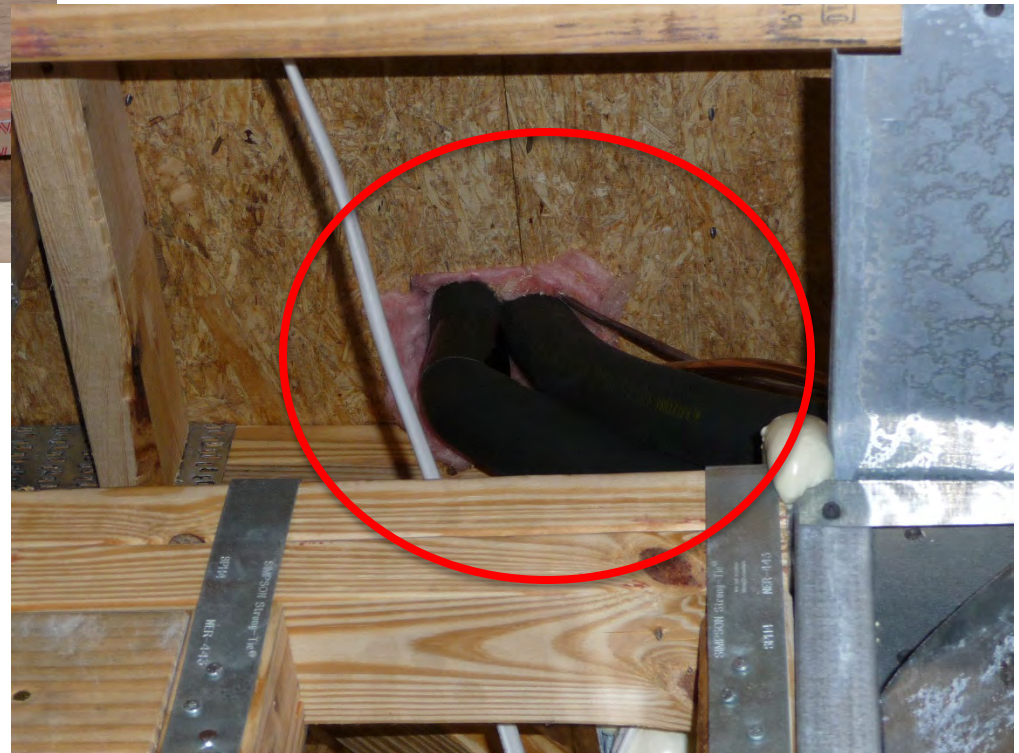
Return Duct Leaks Into Floor Cavity

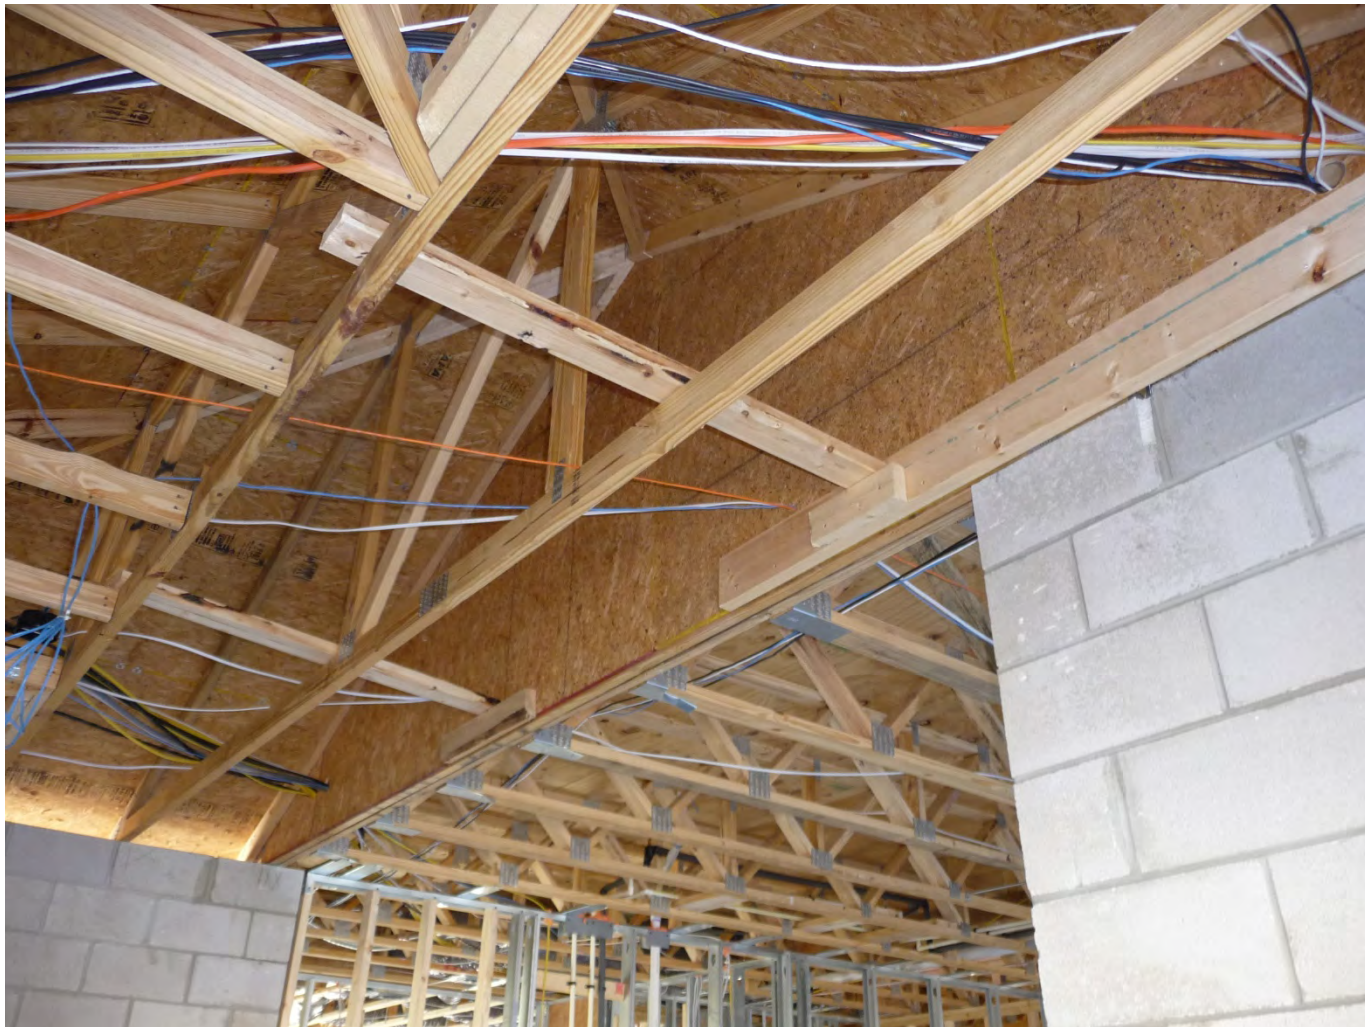
Floor Cavity Covered by Plywood With Adequate Clearance Between Roof Truss and Kneewall For Insulation

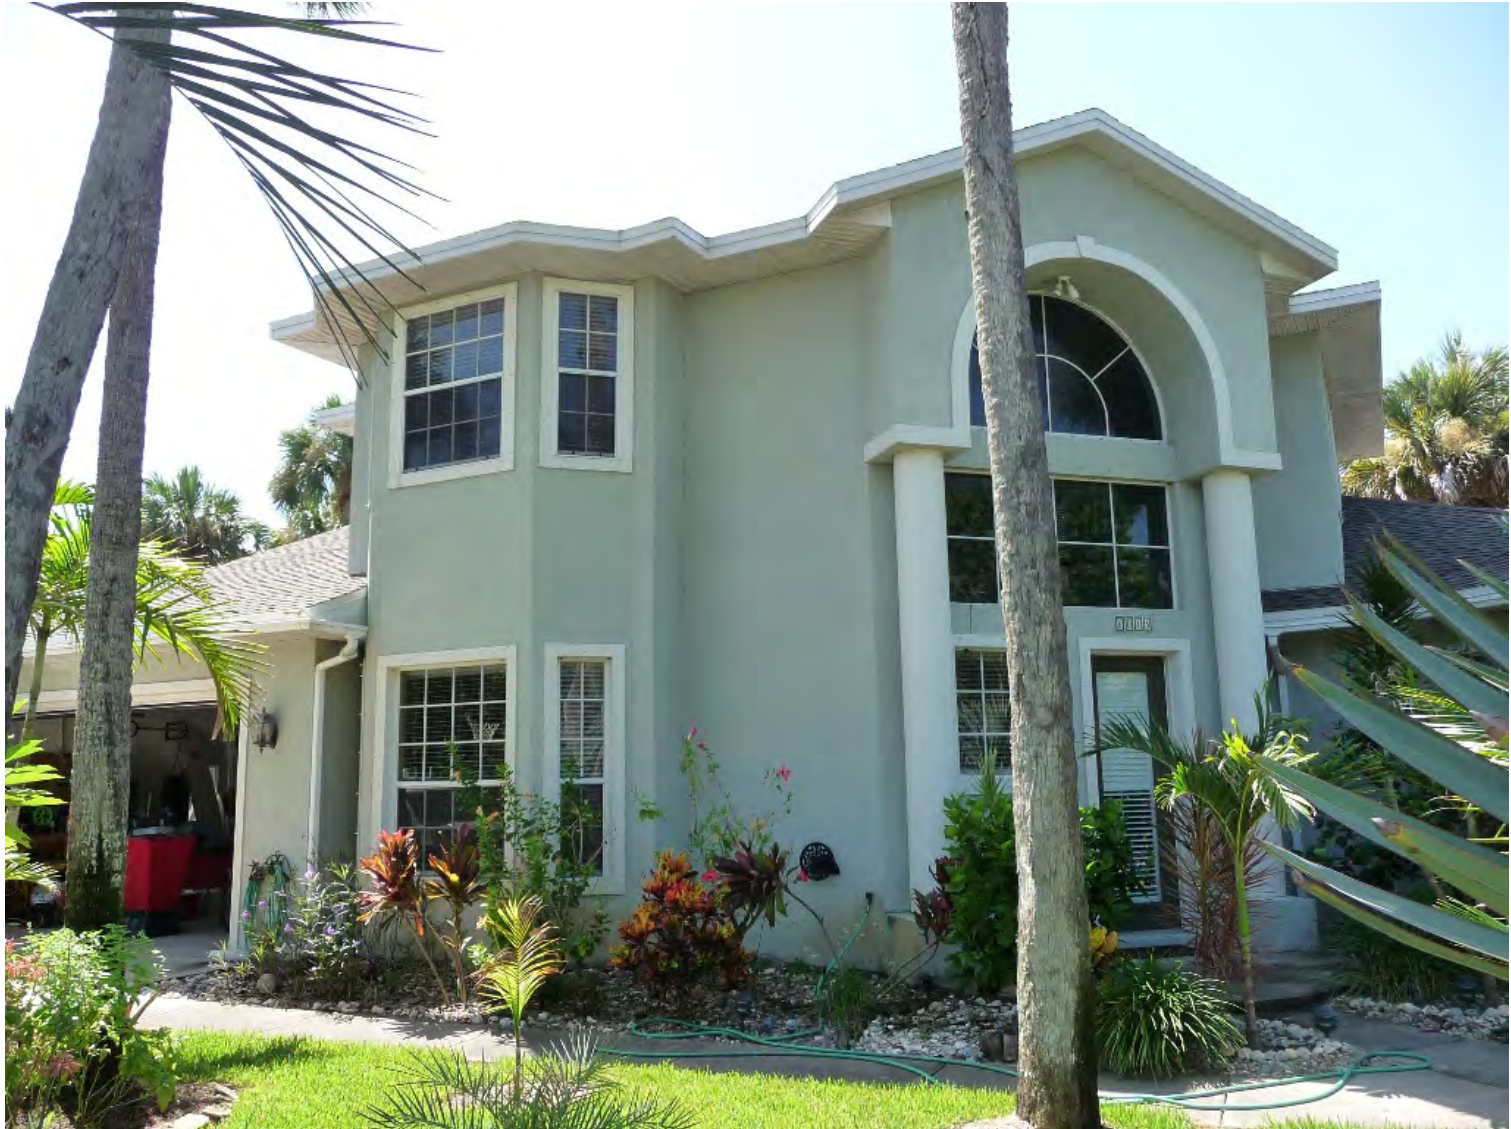
Home with High WW Potential

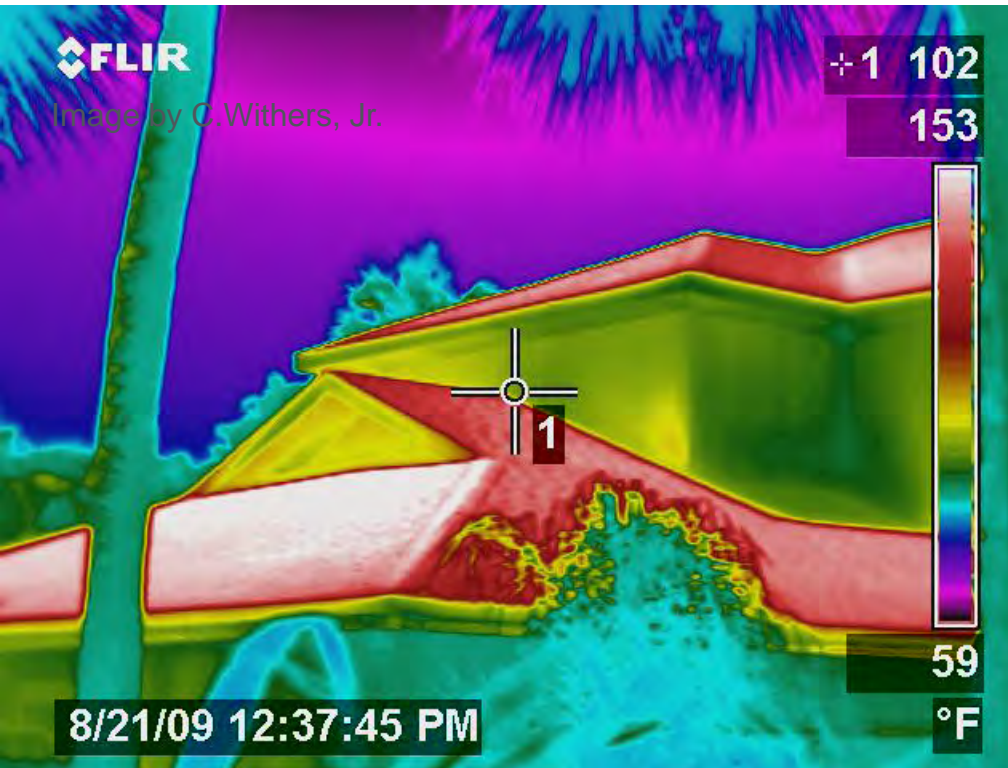
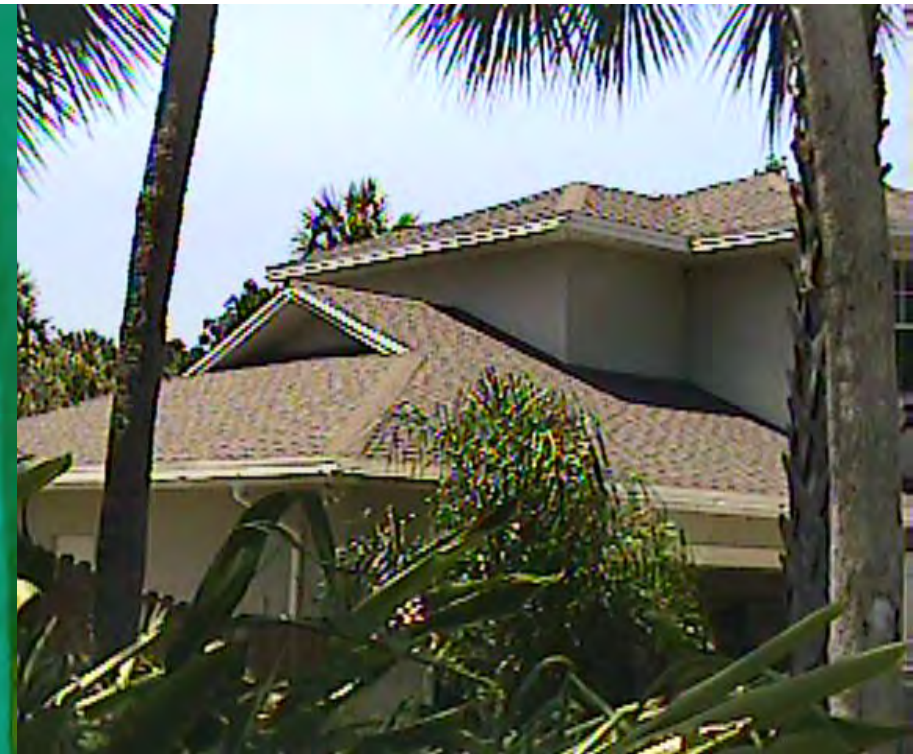
IR Image of Exterior Heated by Sun

Floor cavity open to east and west attics

Wind driven attic air can flow through floor cavity

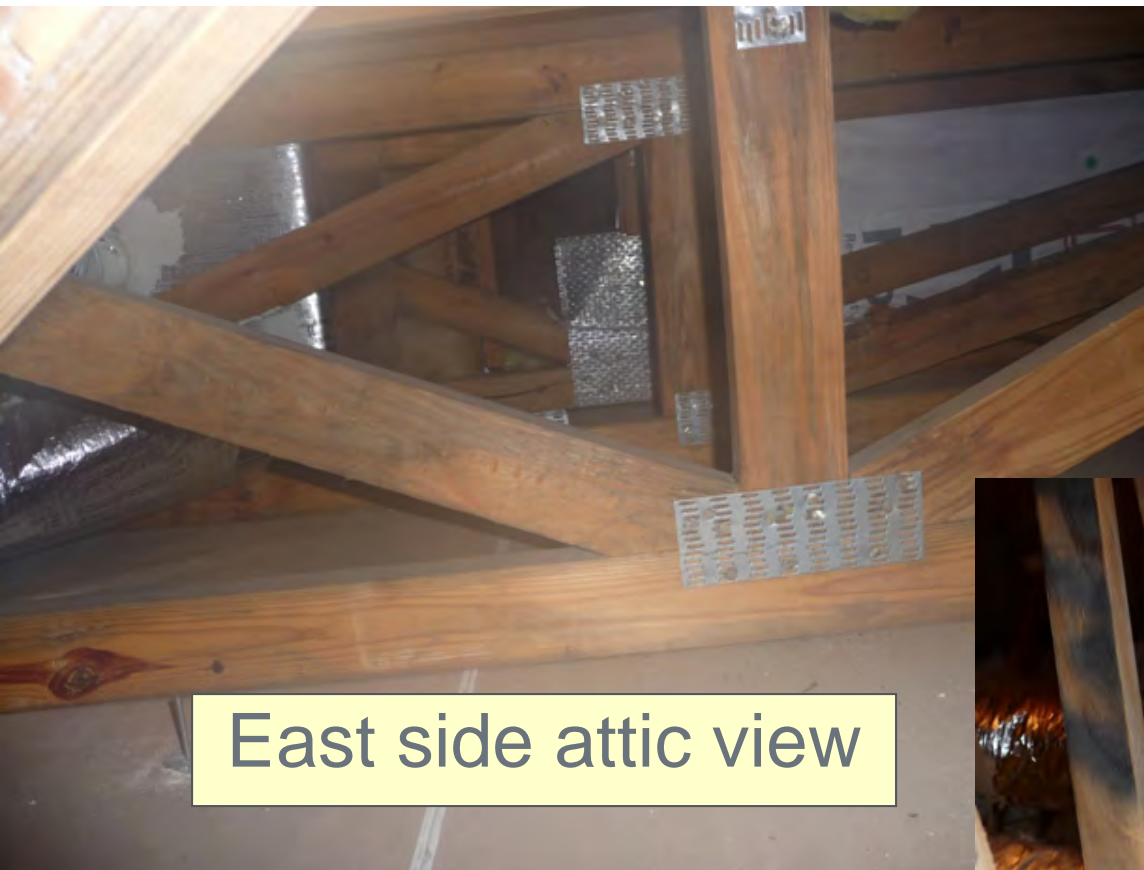
2nd Story Floor Space Open to Vented Attic

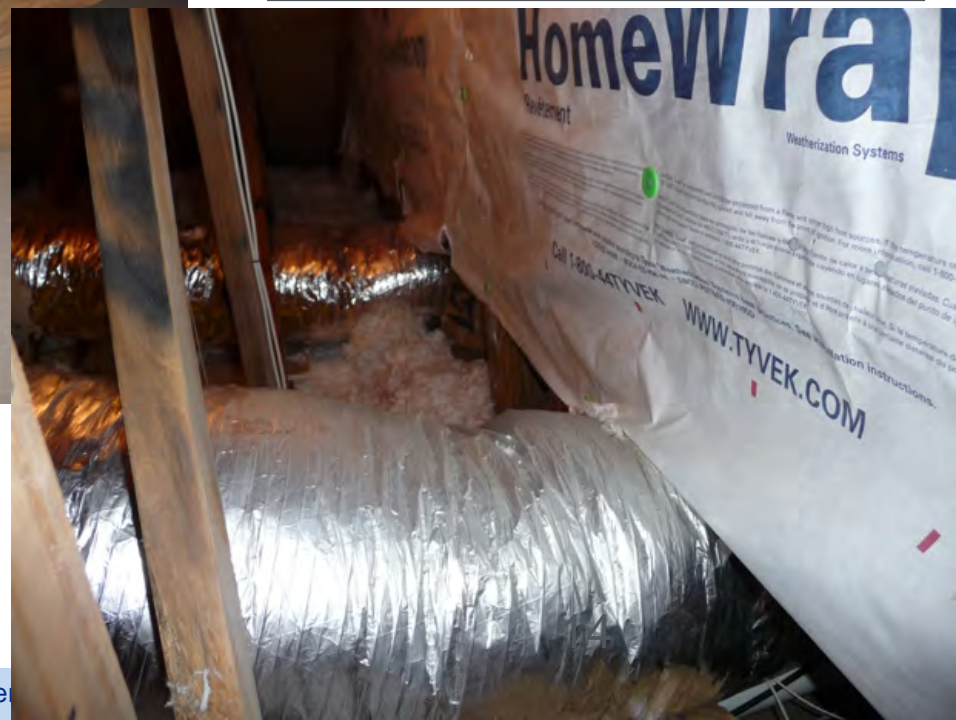
East side attic view

West side attic view

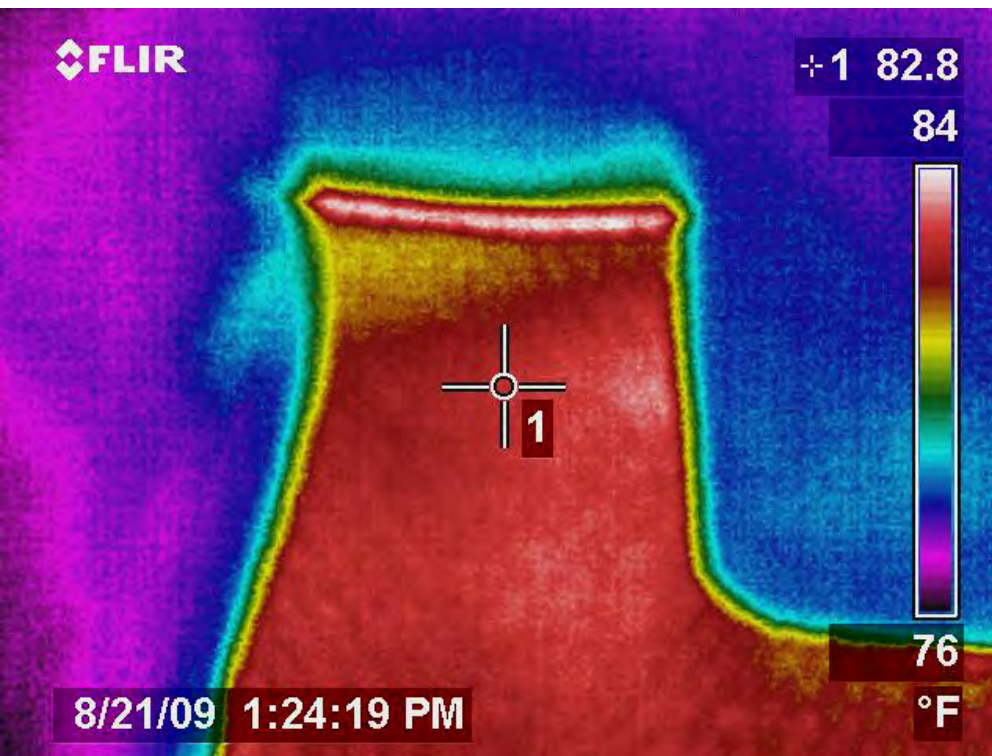
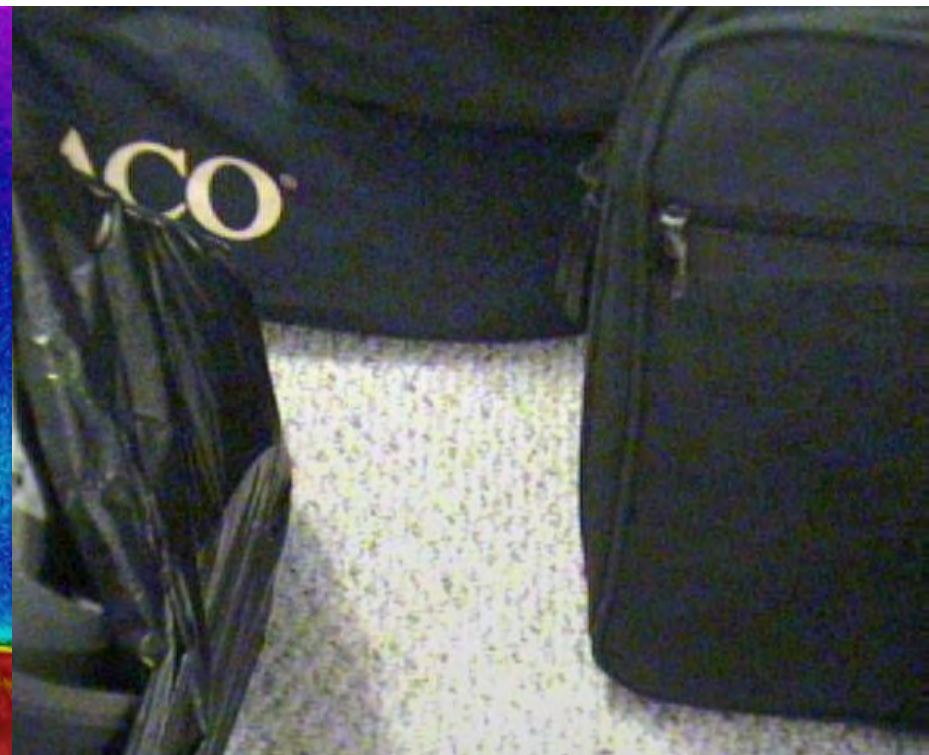
2nd story floor surface is heated by attic air movement into floor space

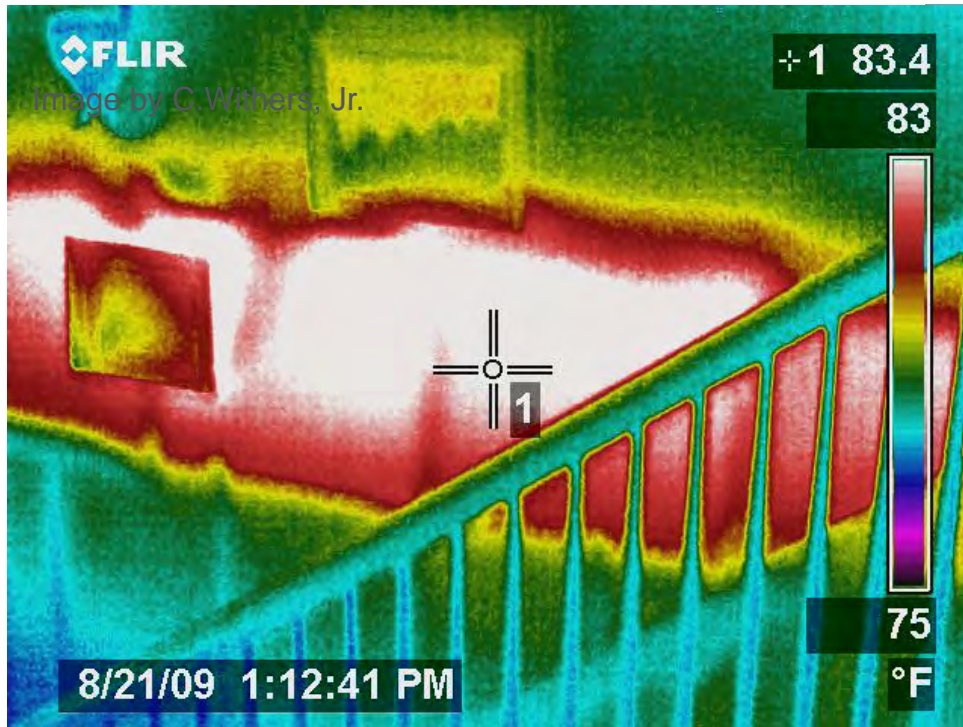
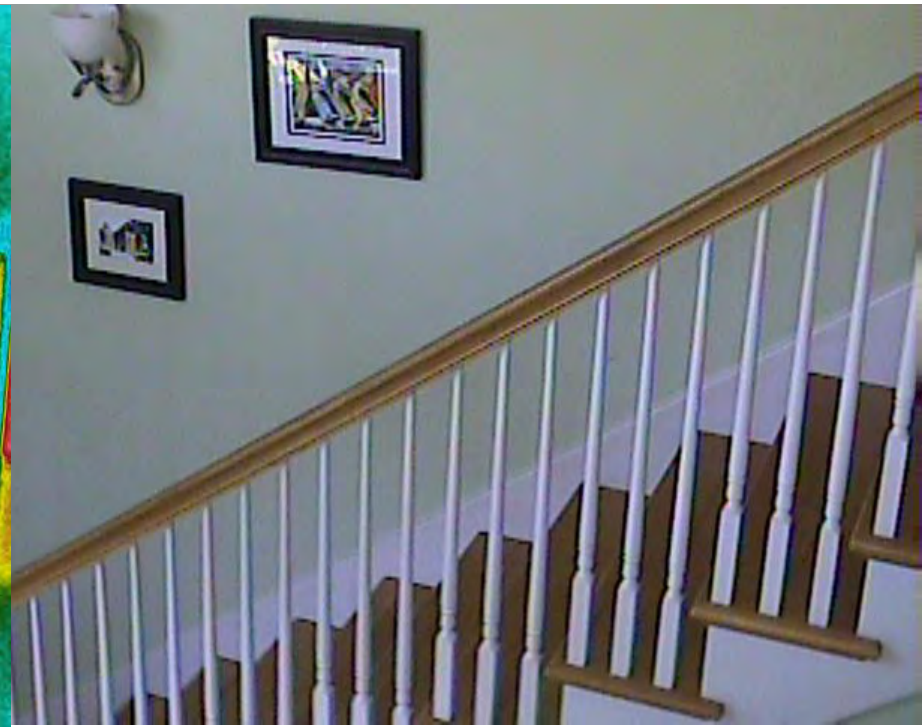
2nd Story Floor Cavity Heated By Attic Air

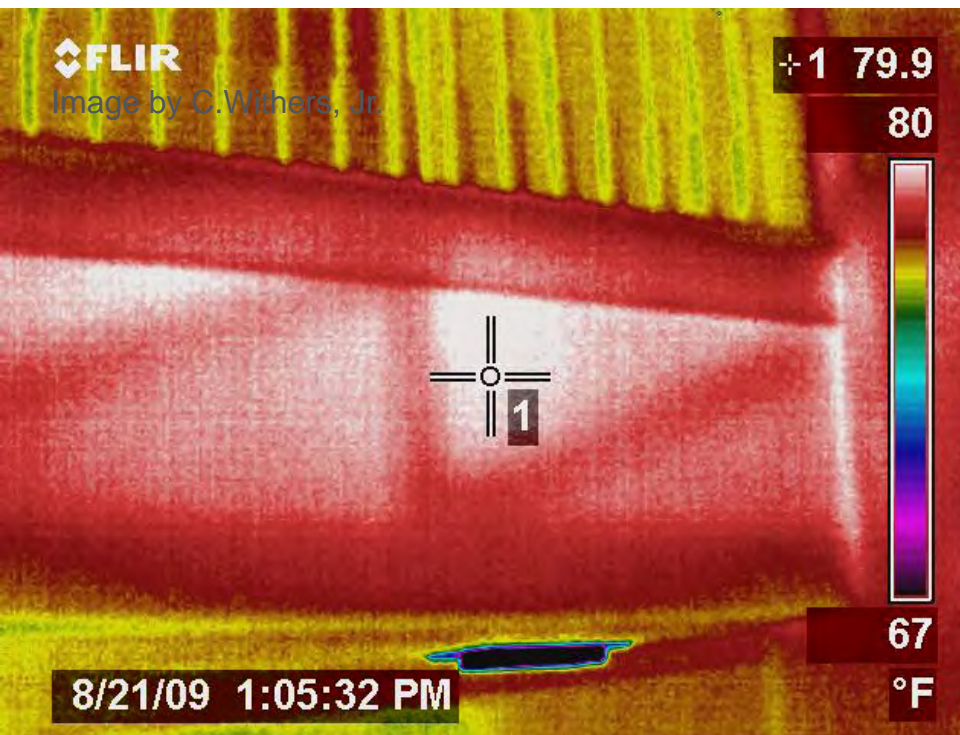
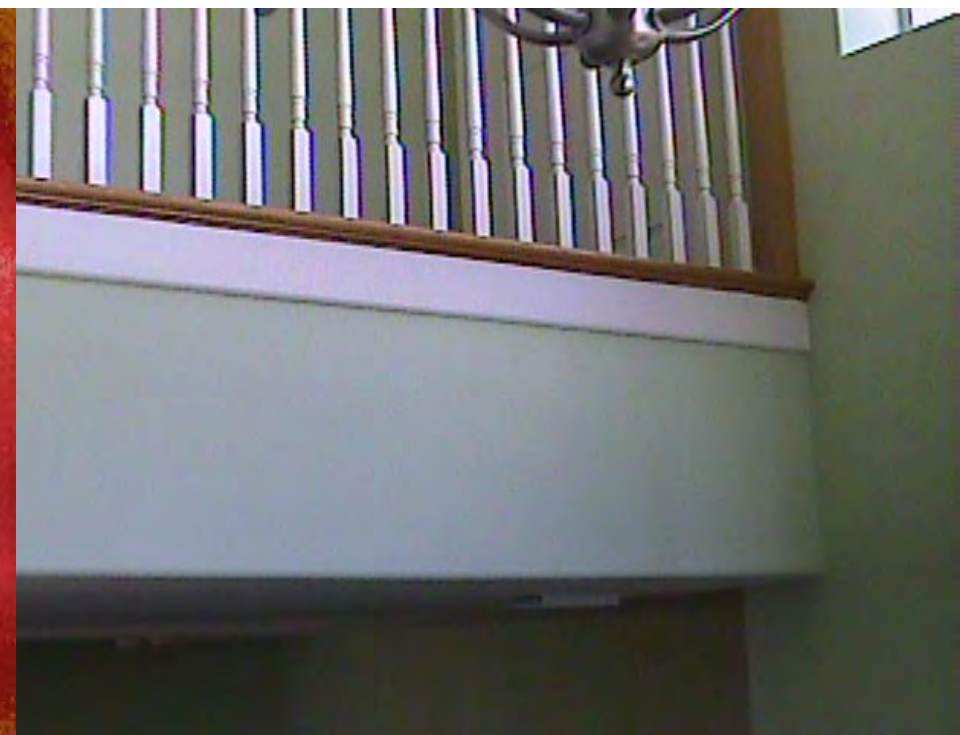
Floor space on other side of very warm wall section.

2nd Story Floor Cavity

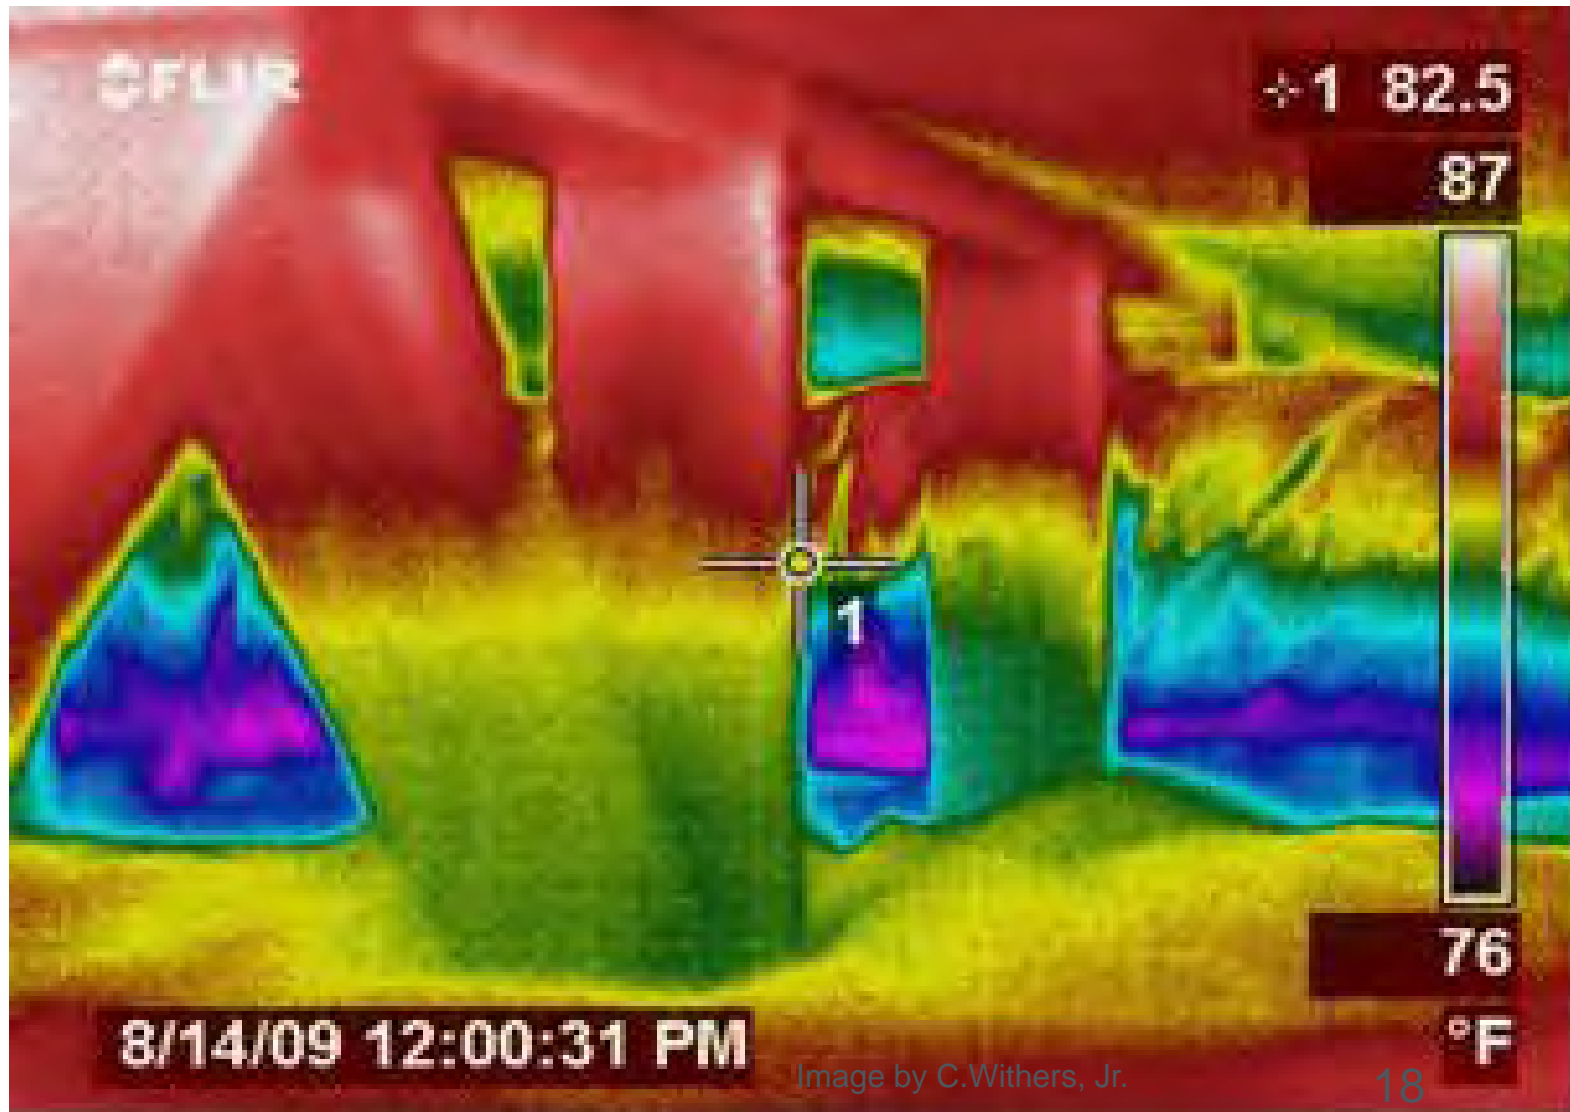
IR Image Taken Inside Floor Cavity

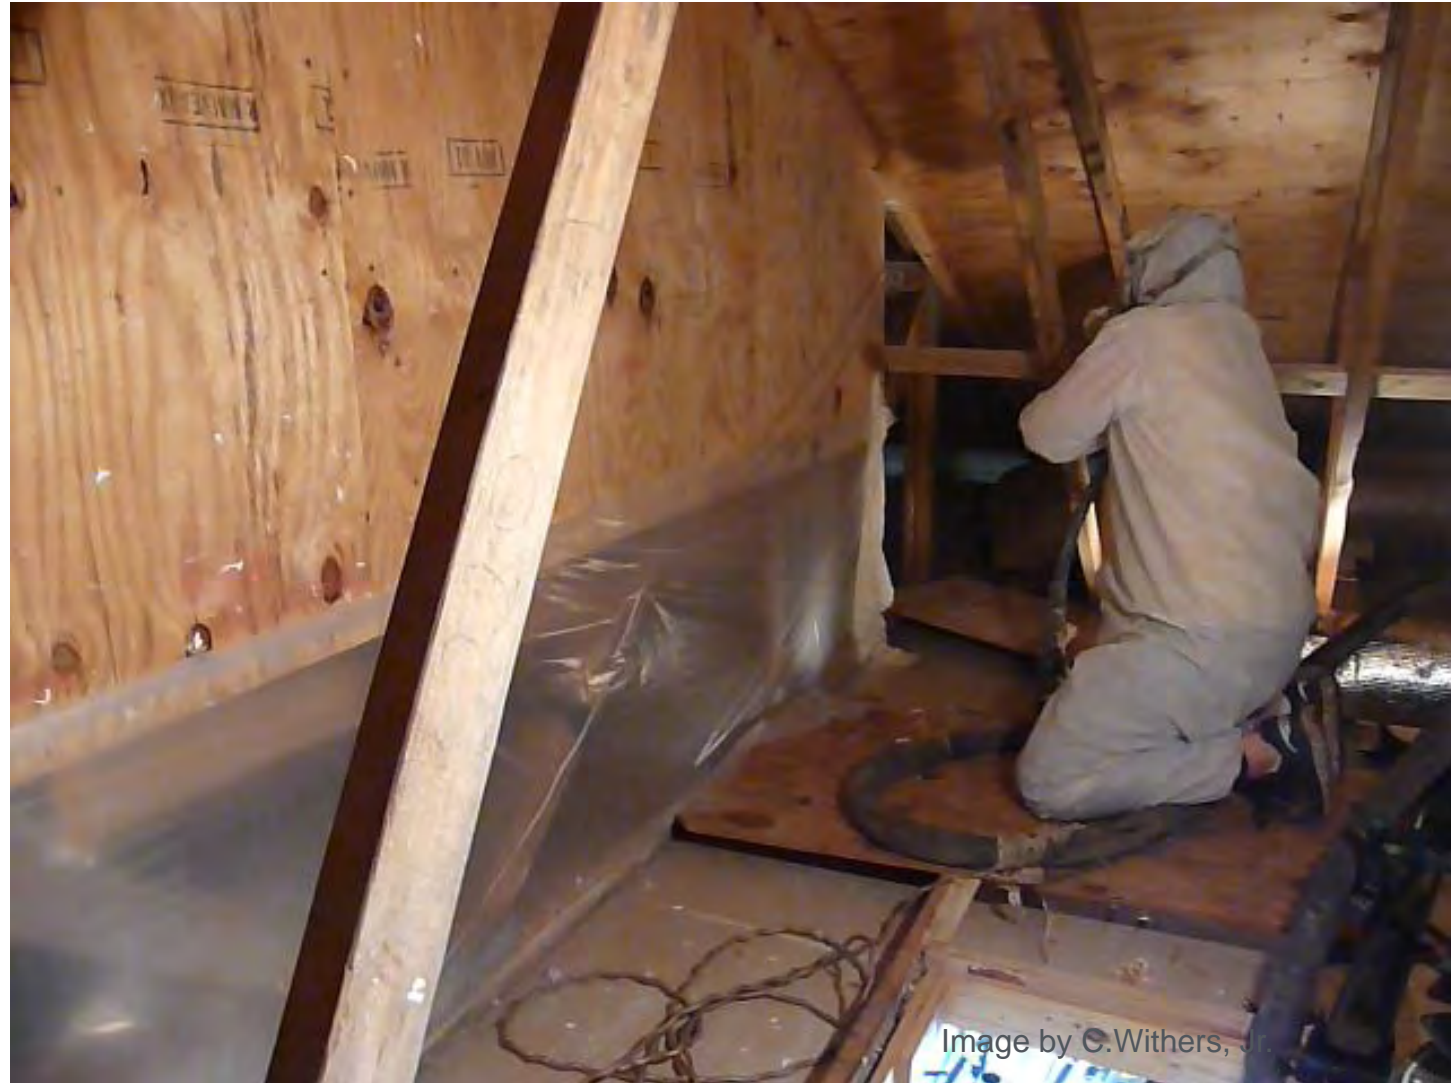
House Repair With Low Density Foam

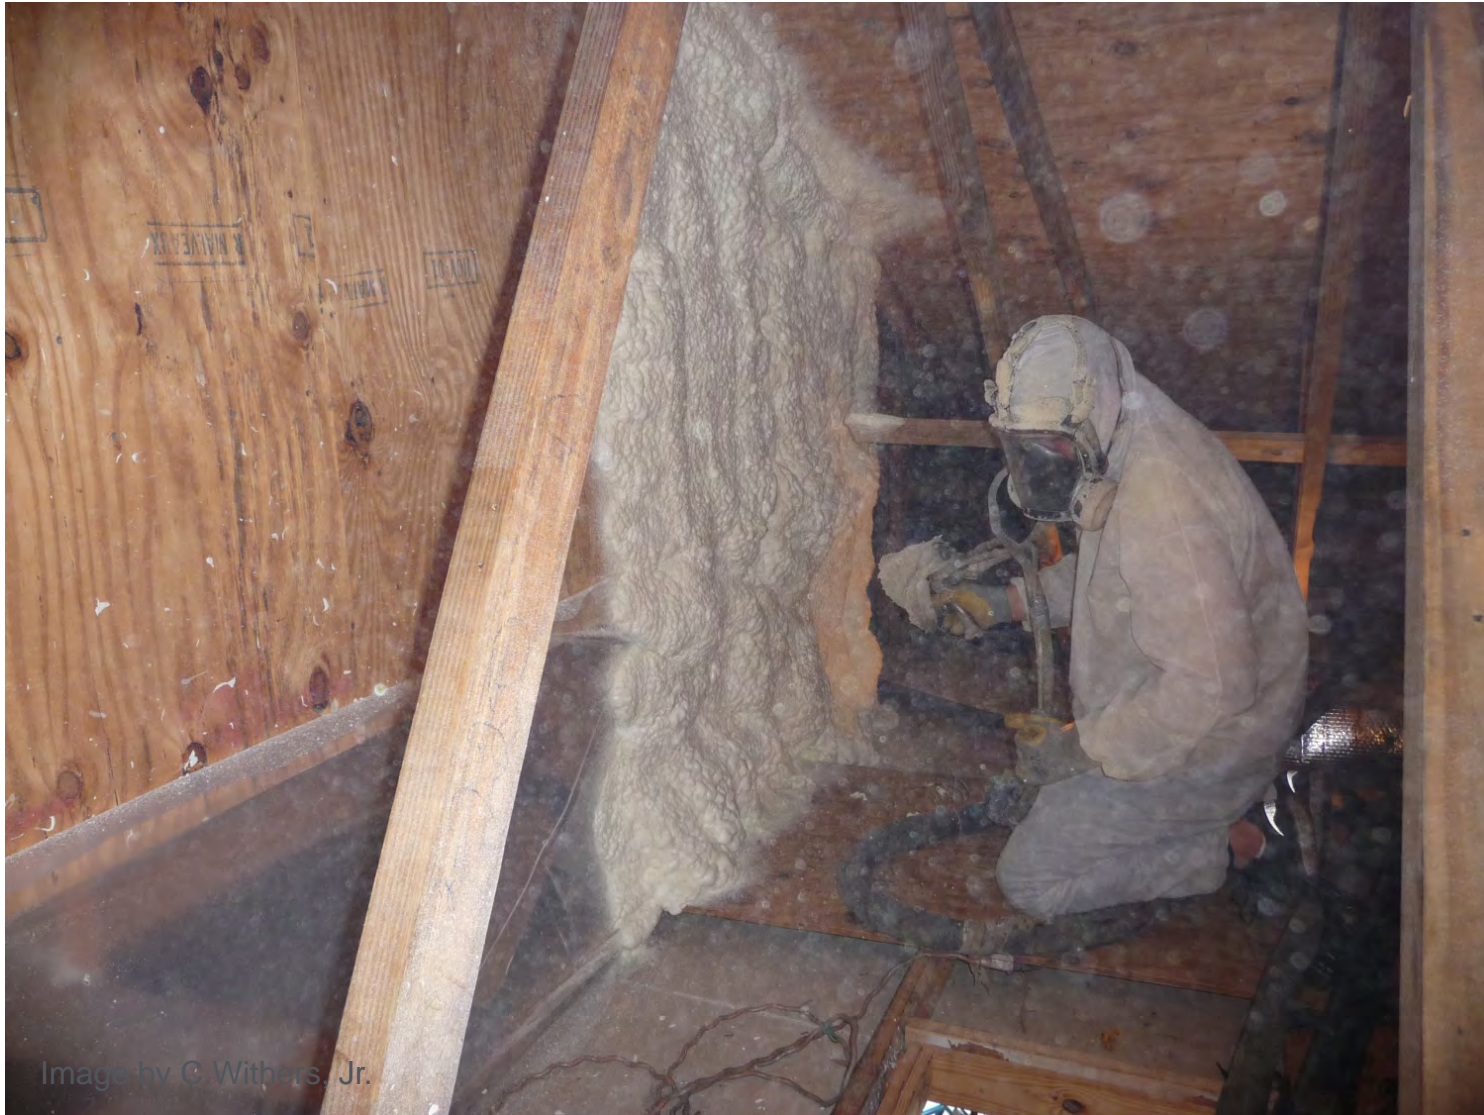
House Repair With Low Density Foam
