Challenges and Solutions for Air Tightening Multistory Homes; Addressing Breaches in Floor Cavity Air and Thermal Barriers

EEBA 2014 St. Louis, Mo
Day 1 Session - 10:30 AM-11:15 AM
September 23, 2014

Addressing Breaches in Floor Cavity Air and Thermal Barriers in Multi-Story Homes

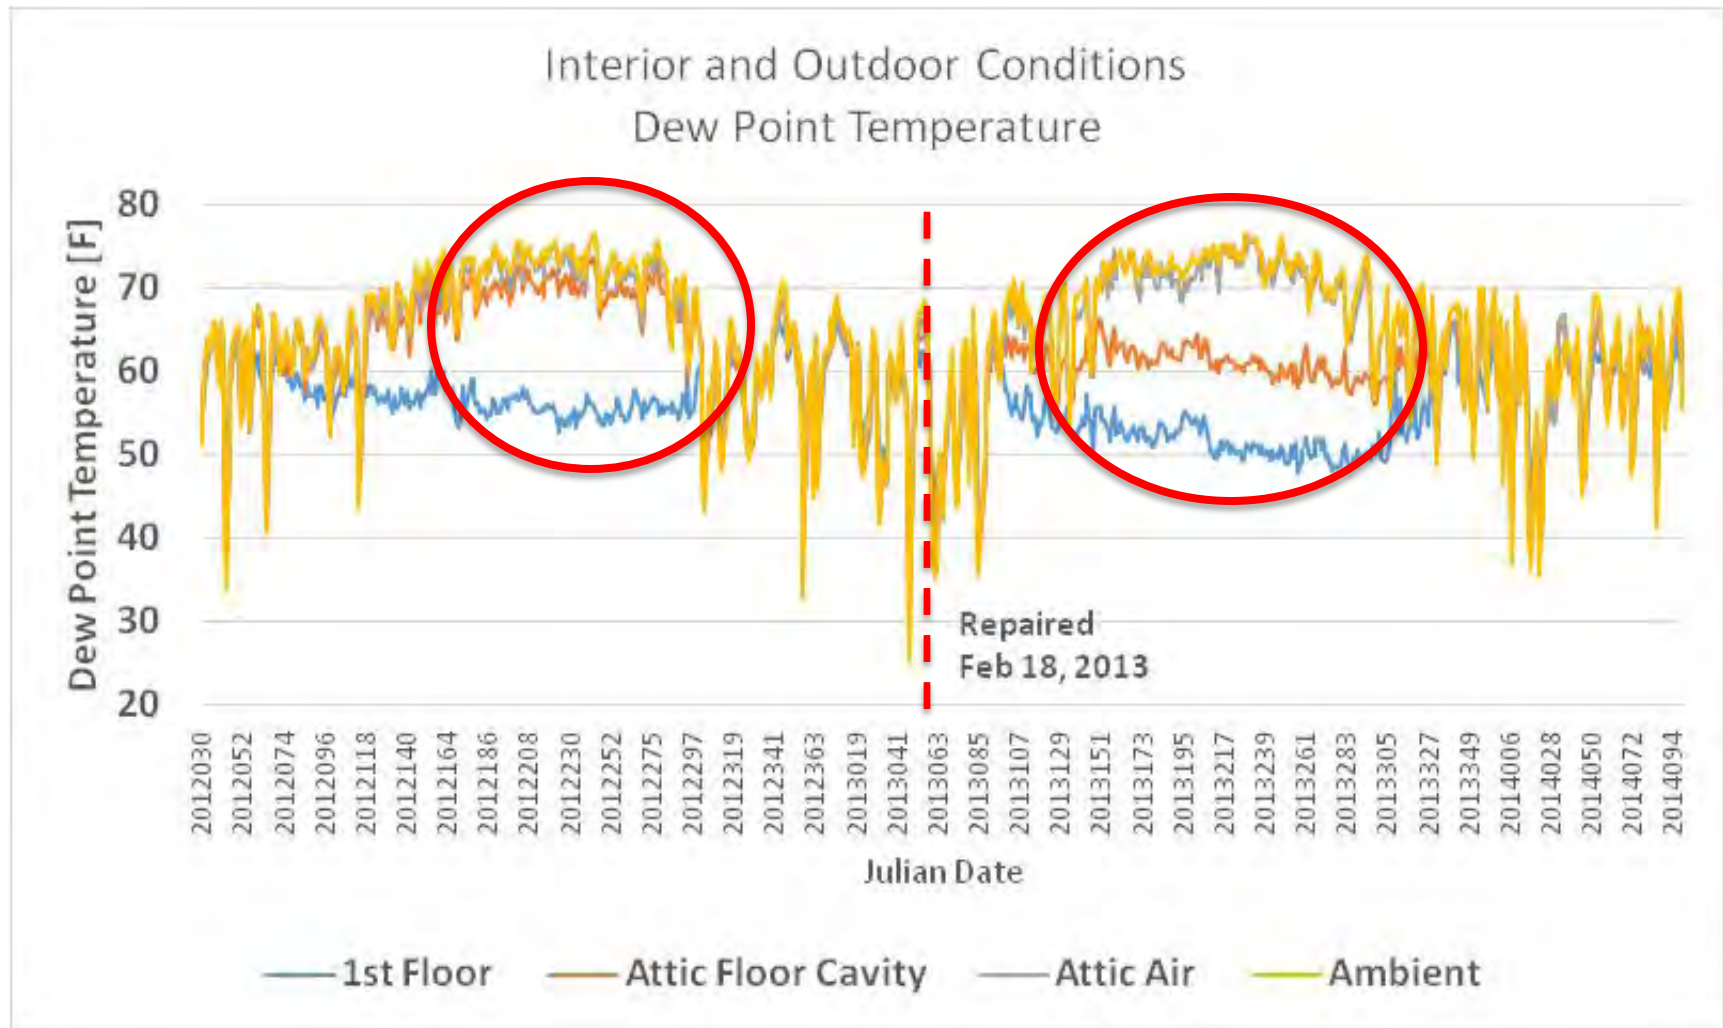
House Floor Cavity Repair Impact

Cooling savings 10.5%; floor cavity dewpoint drops; no heating savings.

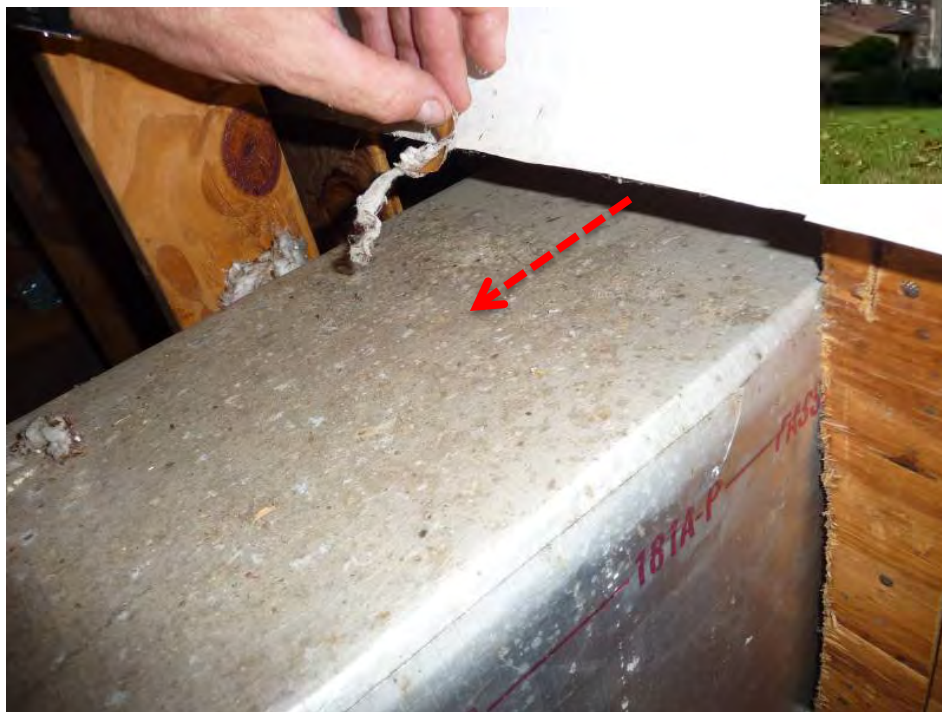
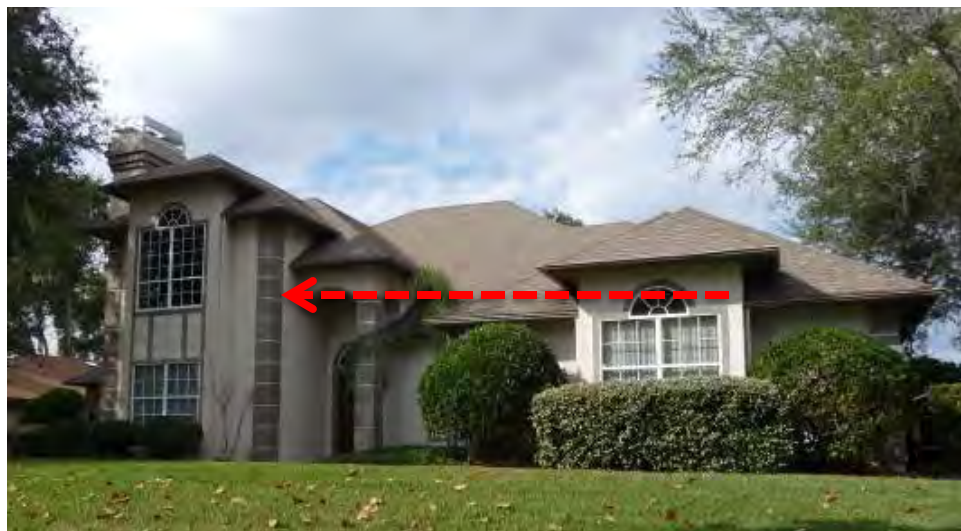
Floor Cavity Repair Using Batt Insulation

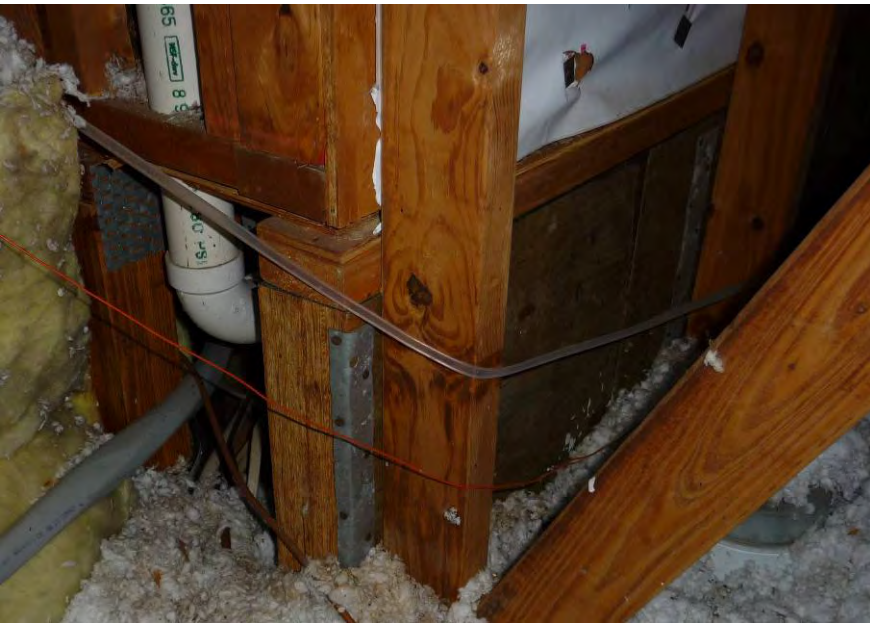
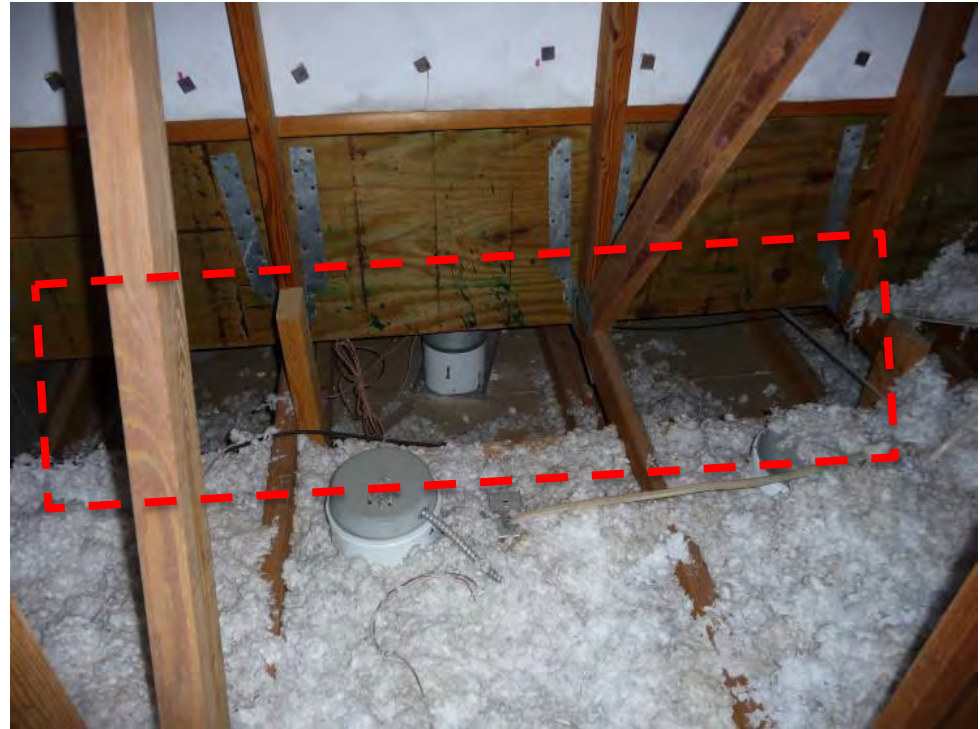
Floor Cavity Repair Using Batt Insulation

As found, open pathways due to dropped kitchen ceiling area (right) and around utility penetrations (below).

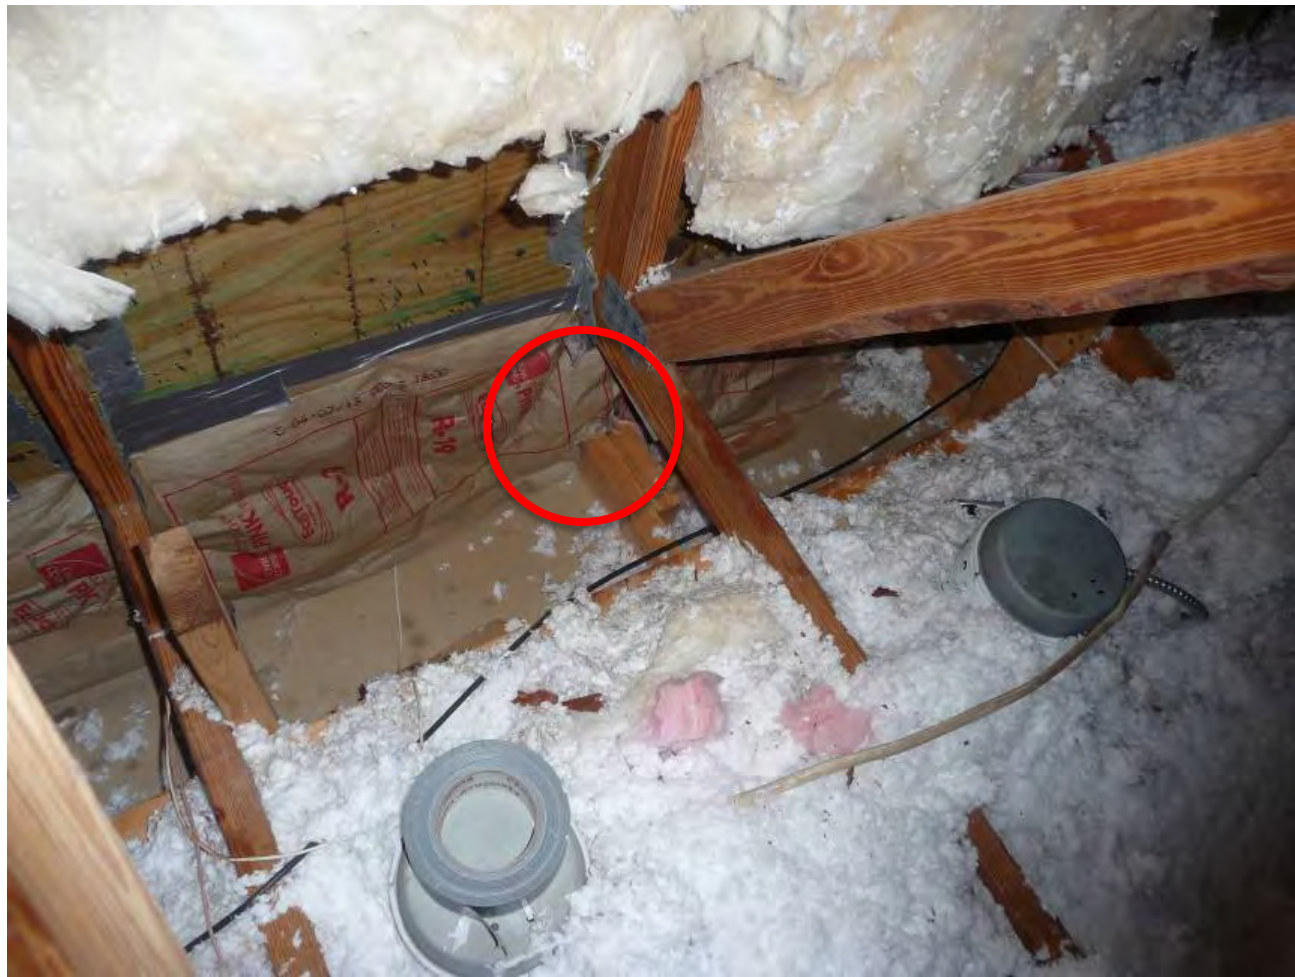
Floor Cavity Repair Using Batt Insulation

Faced batts can be used if installed carefully. Cut edges to fit penetrations. Mechanically fasten and seal at perimeter. (Duct tape does neither of these).

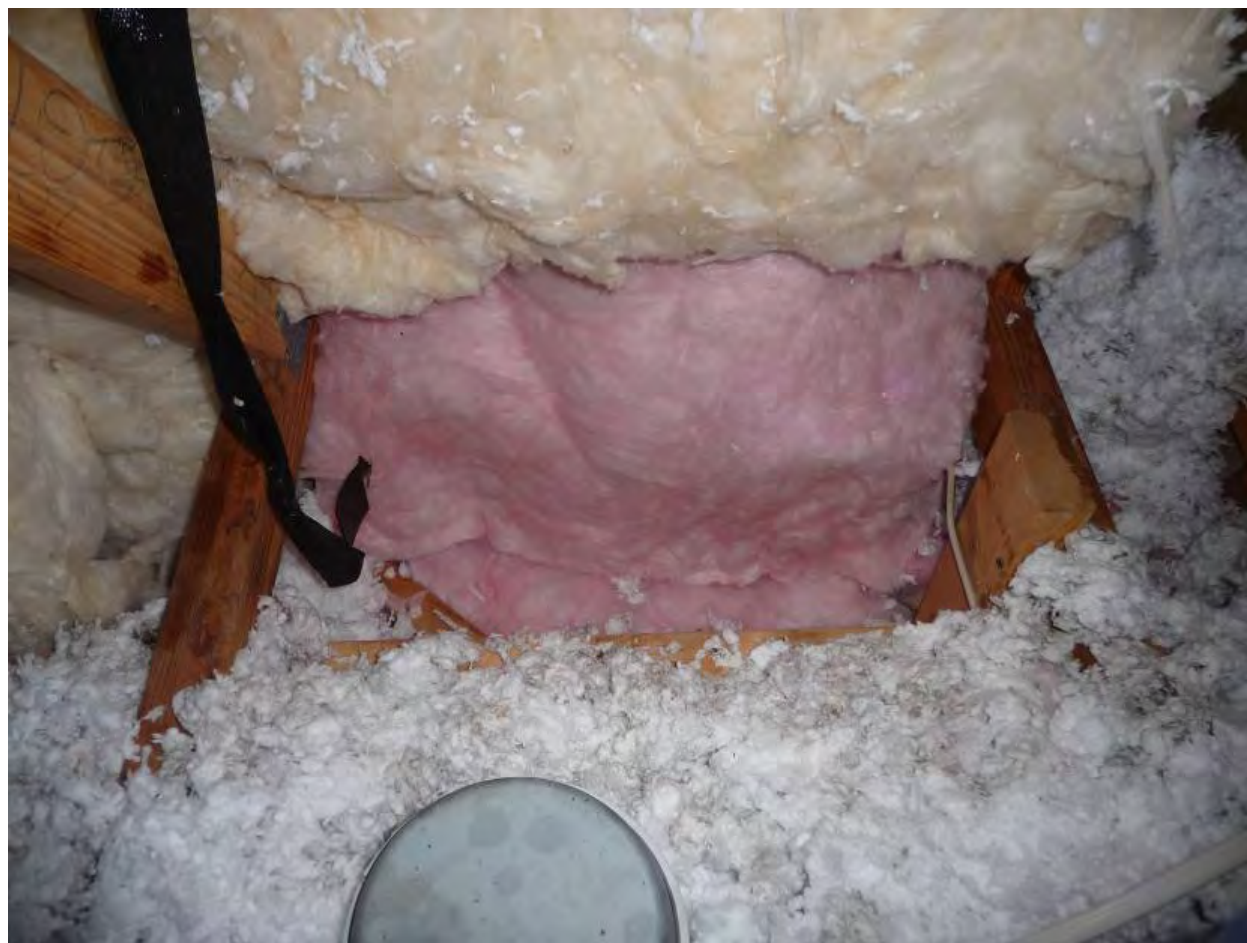
Floor Cavity Repair Using Batt Insulation

Faced batts can be used if installed carefully.

Paper face should not be exposed to attic according to building code (fire safety).

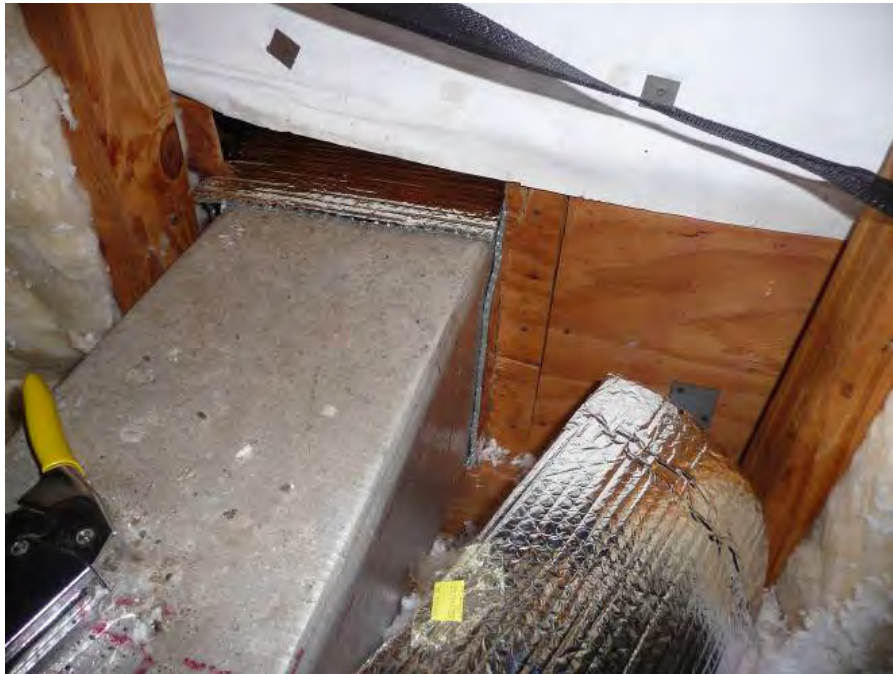
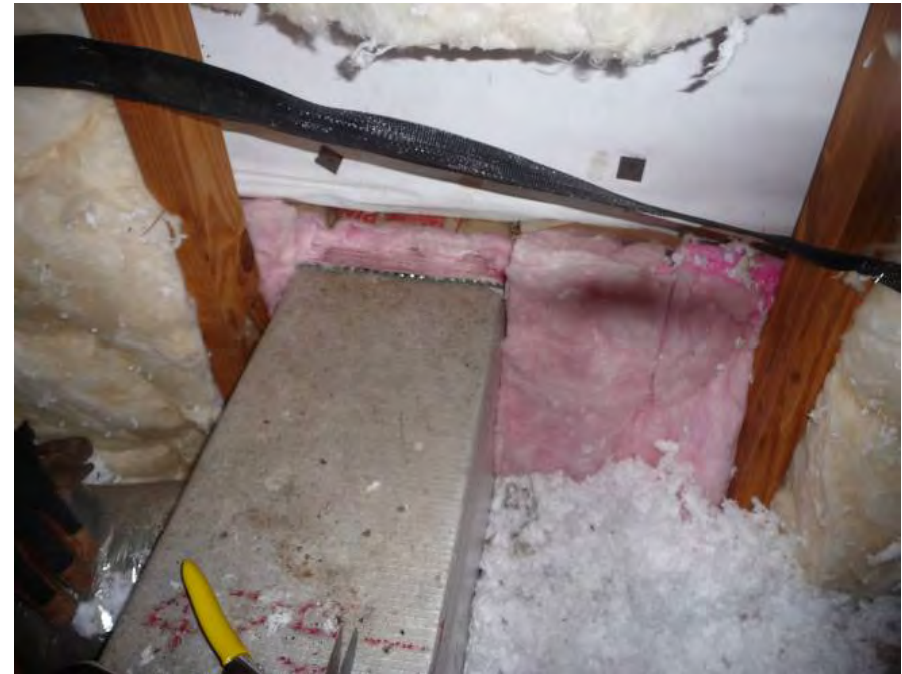
Floor Cavity Repair Using Batt Insulation

1. Insulated vapor retarder (0.1-0.5 perms) against the cold supply duct, before placing any vapor permeable insulation directly against duct.
2. Batt insulation sealed in place between duct and surrounding area.

Results: 6% cooling savings and 20% heating savings

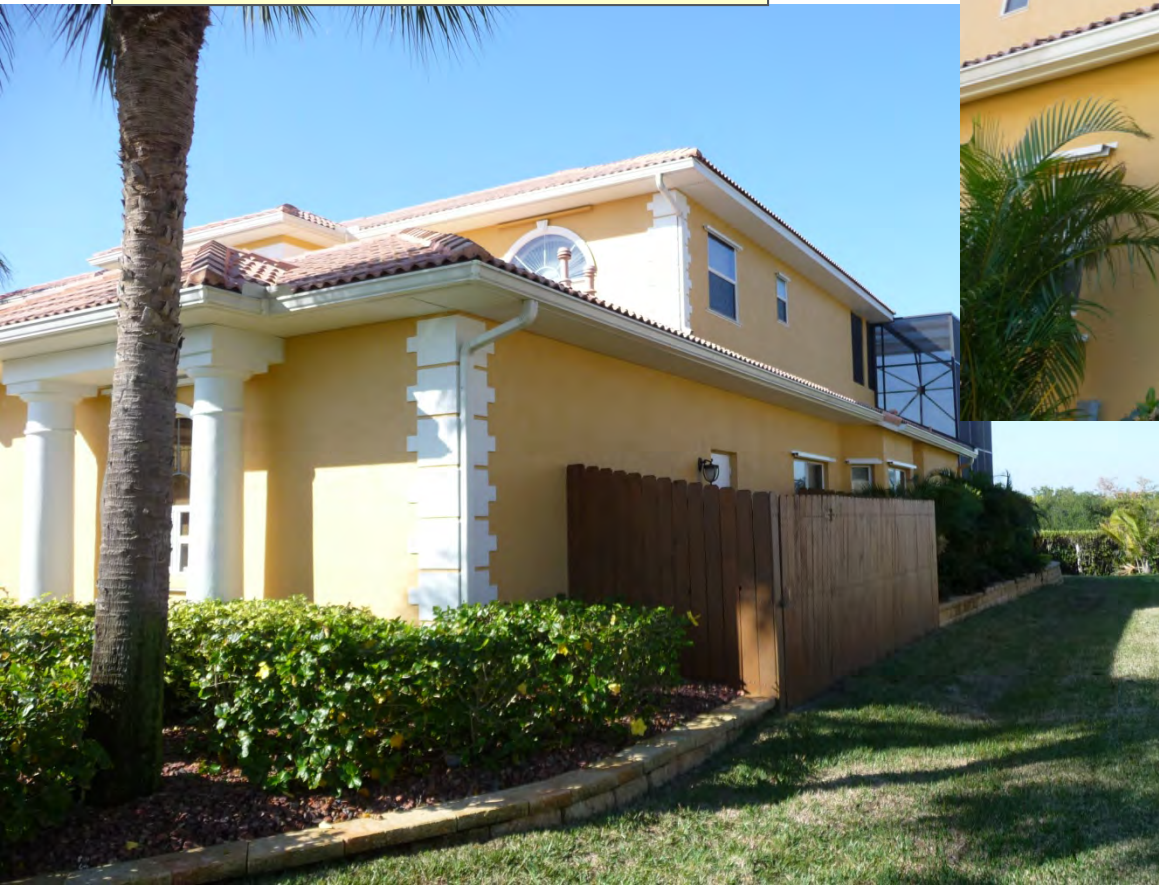
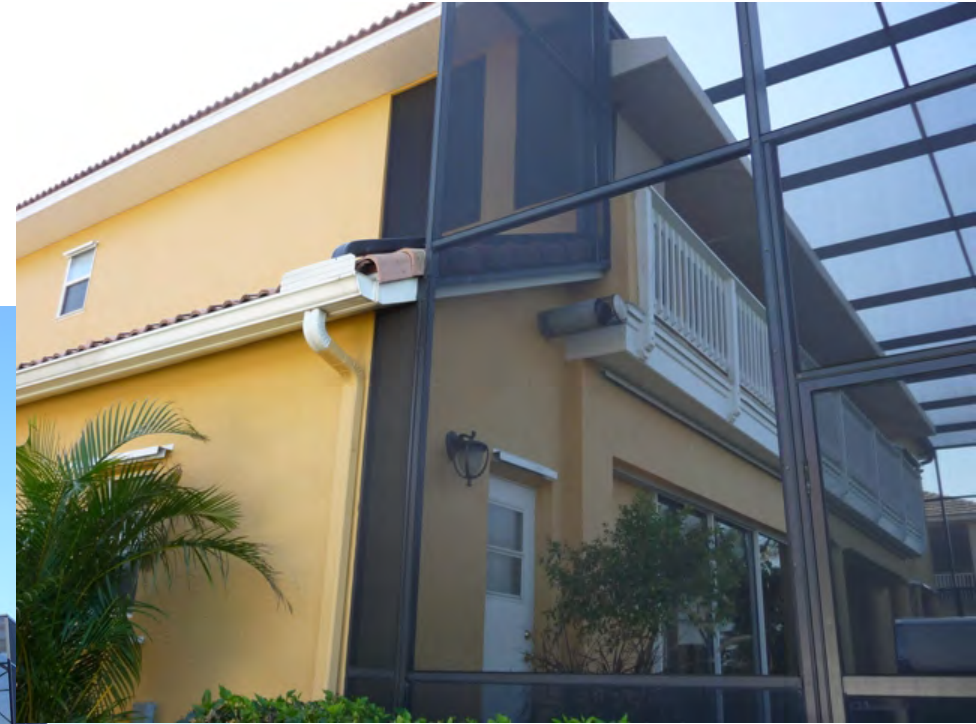
Complimentary Pathway Through Floor East to West

NE corner view

NW corner view

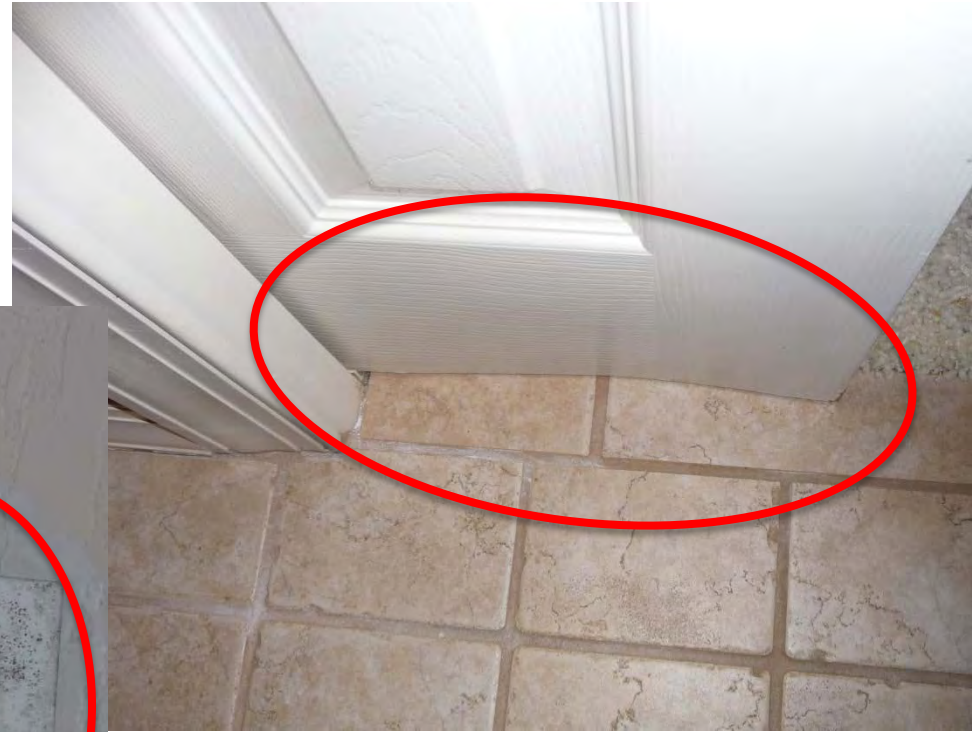
Home Had History of Moisture Control Problems

- Mildew stains and moisture on supply grills
- Condensation on duct in floor space dripping onto first floor ceiling.

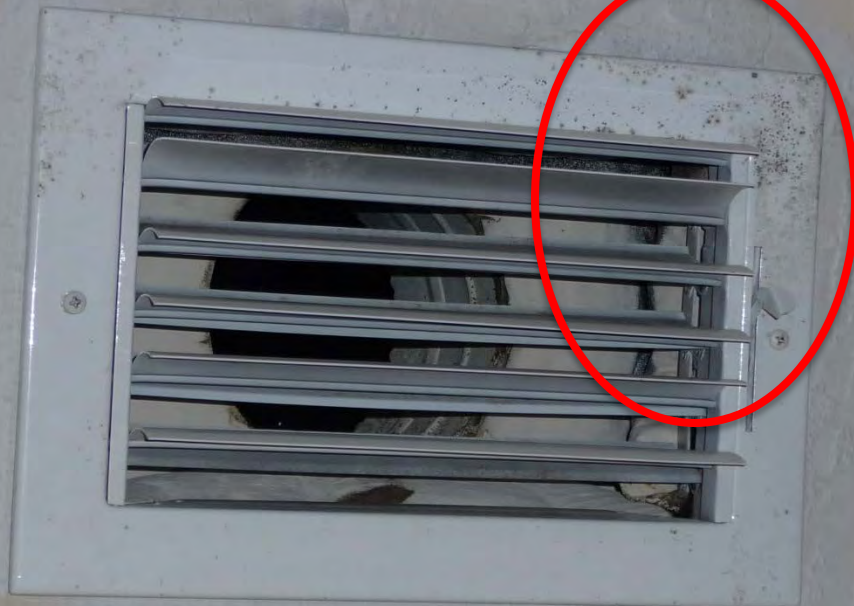
- Warped pocket door

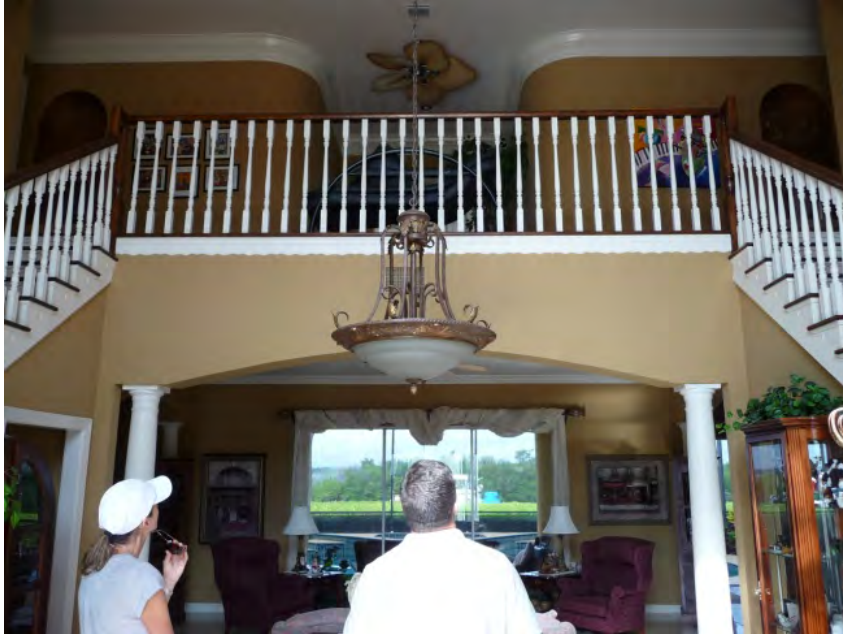
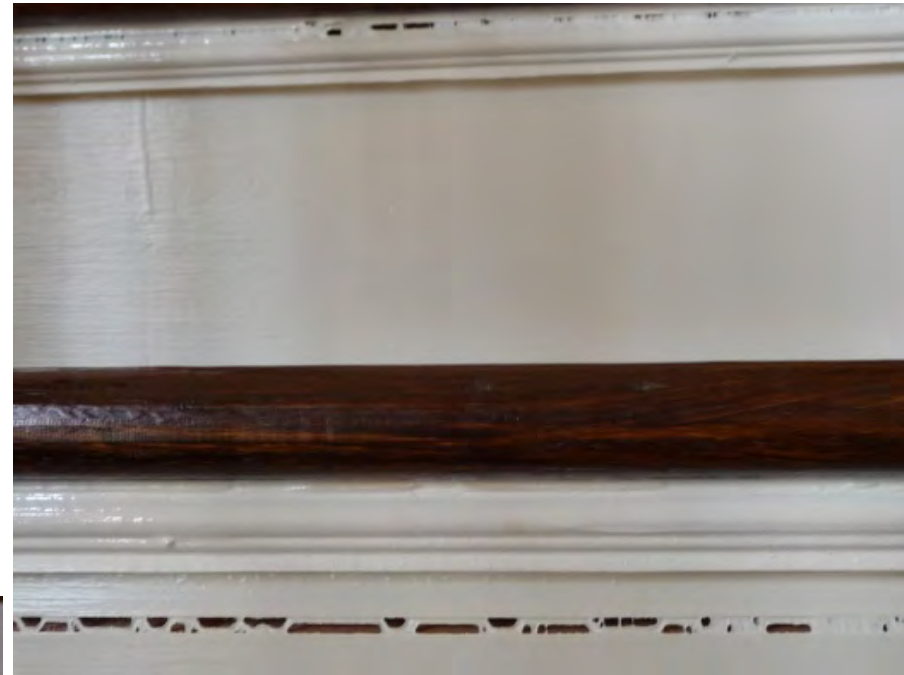
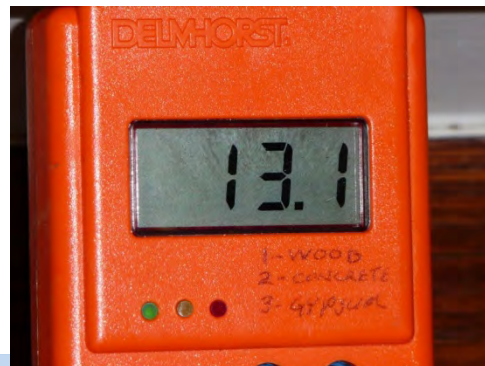
Moisture Damaged Stairs, Floors and Ceilings

- Moisture damage before repair on stair risers

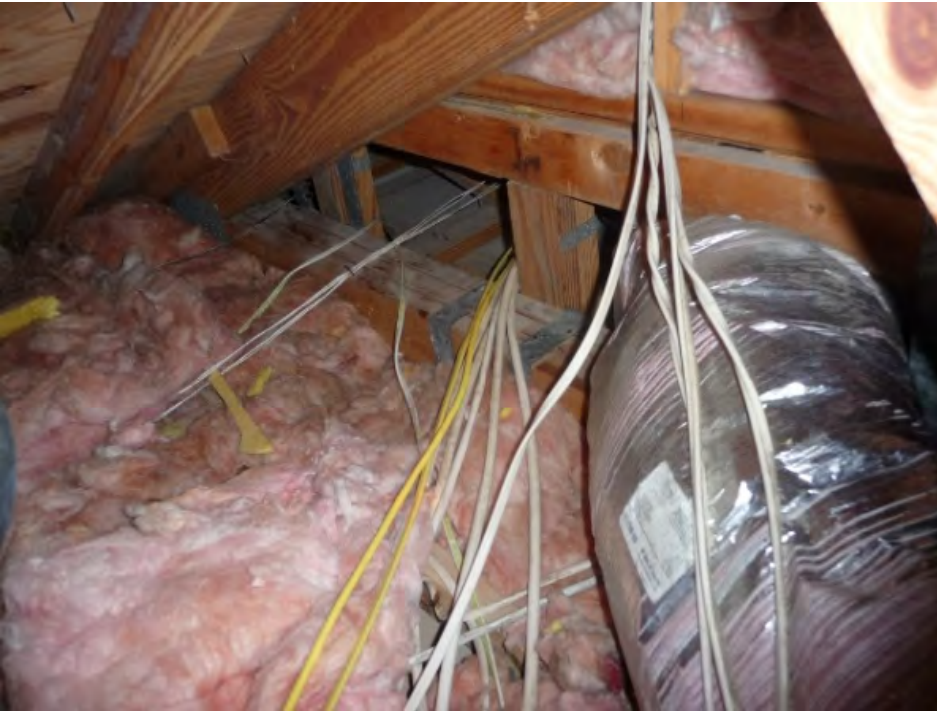
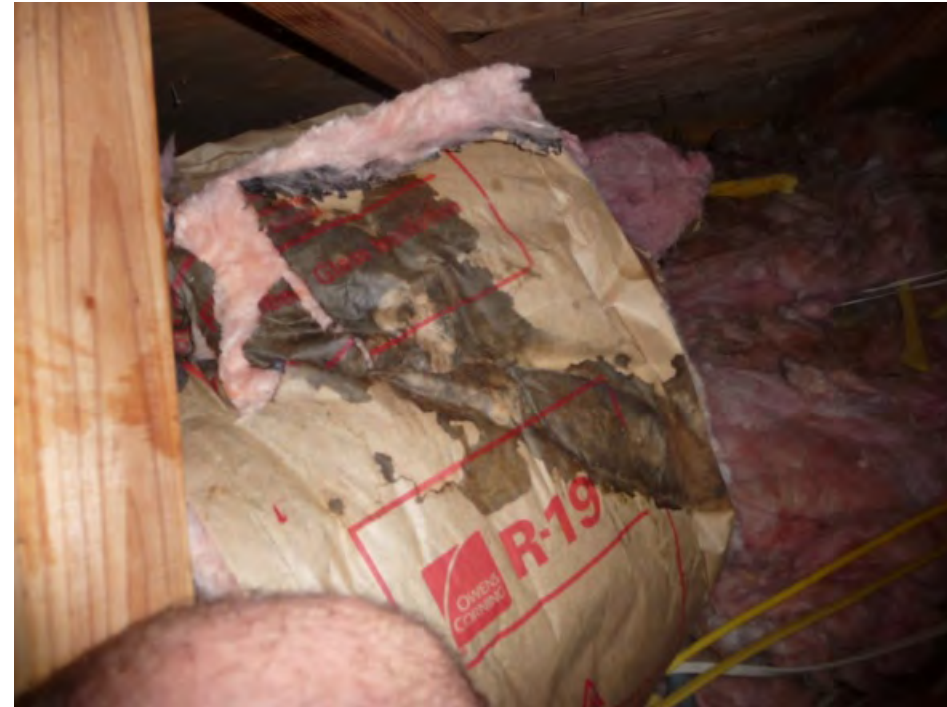
Wind Wash Floor Cavity Inspection

- Inside east attic view of open floor space

Insulation in direct contact with cold supply duct results in condensation on duct and insulation. Sealing floor space around ducts must be done right.

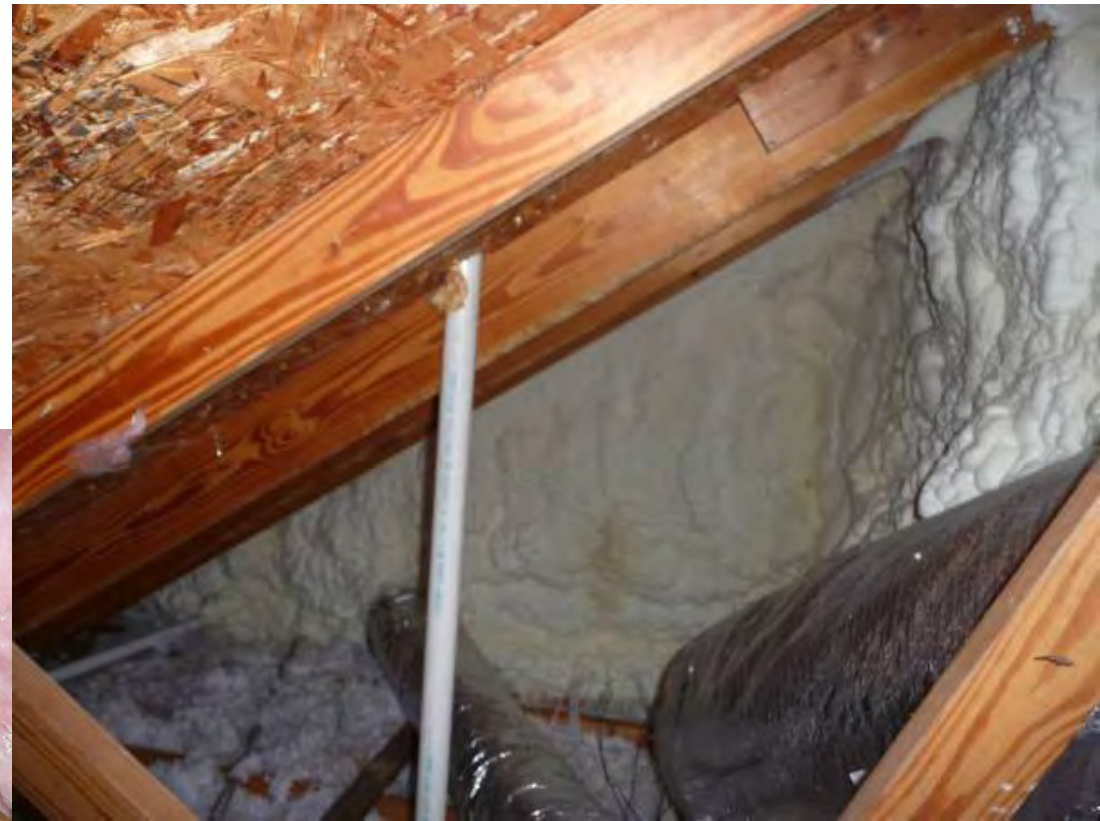
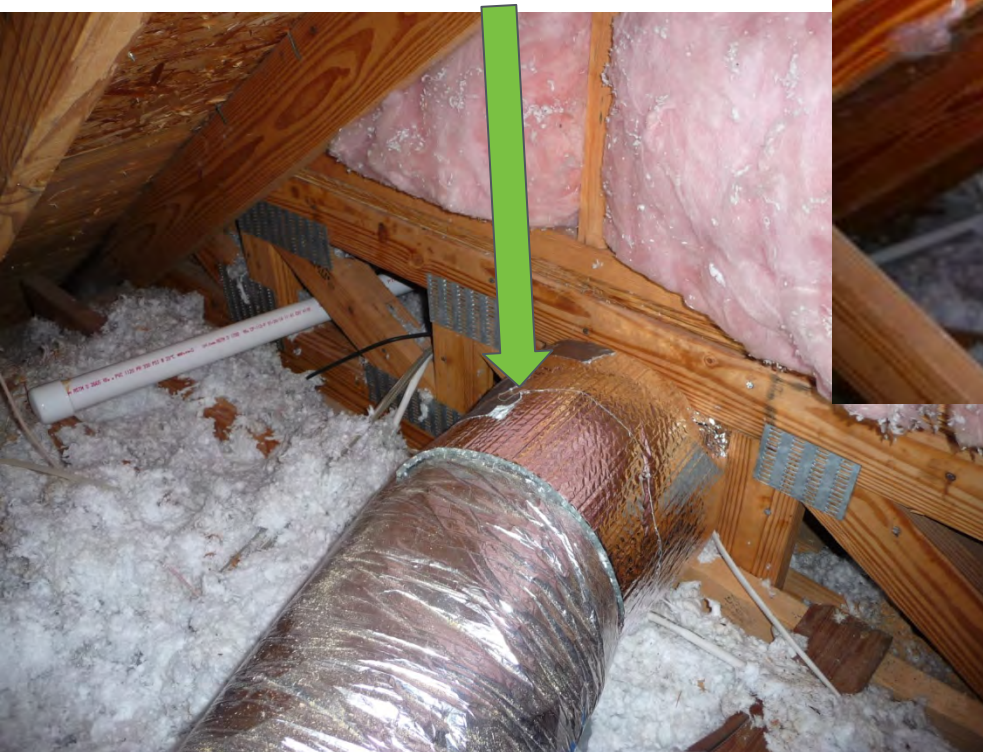
Wind Wash Repair

Insulation with vapor retarder placed around ducts before spray foam application.

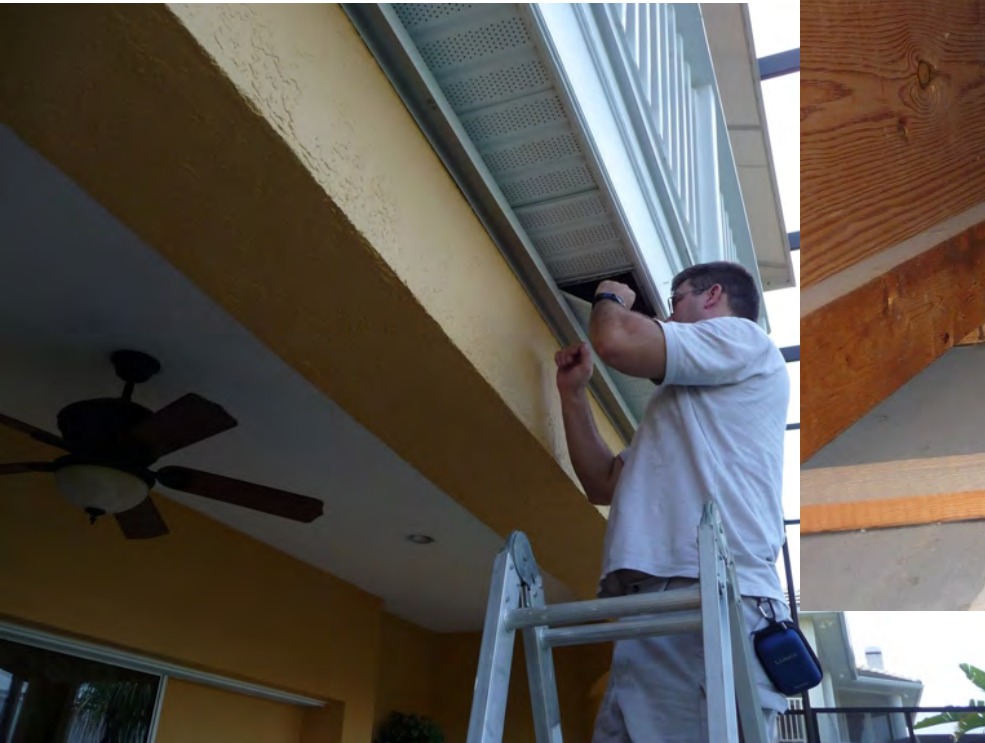
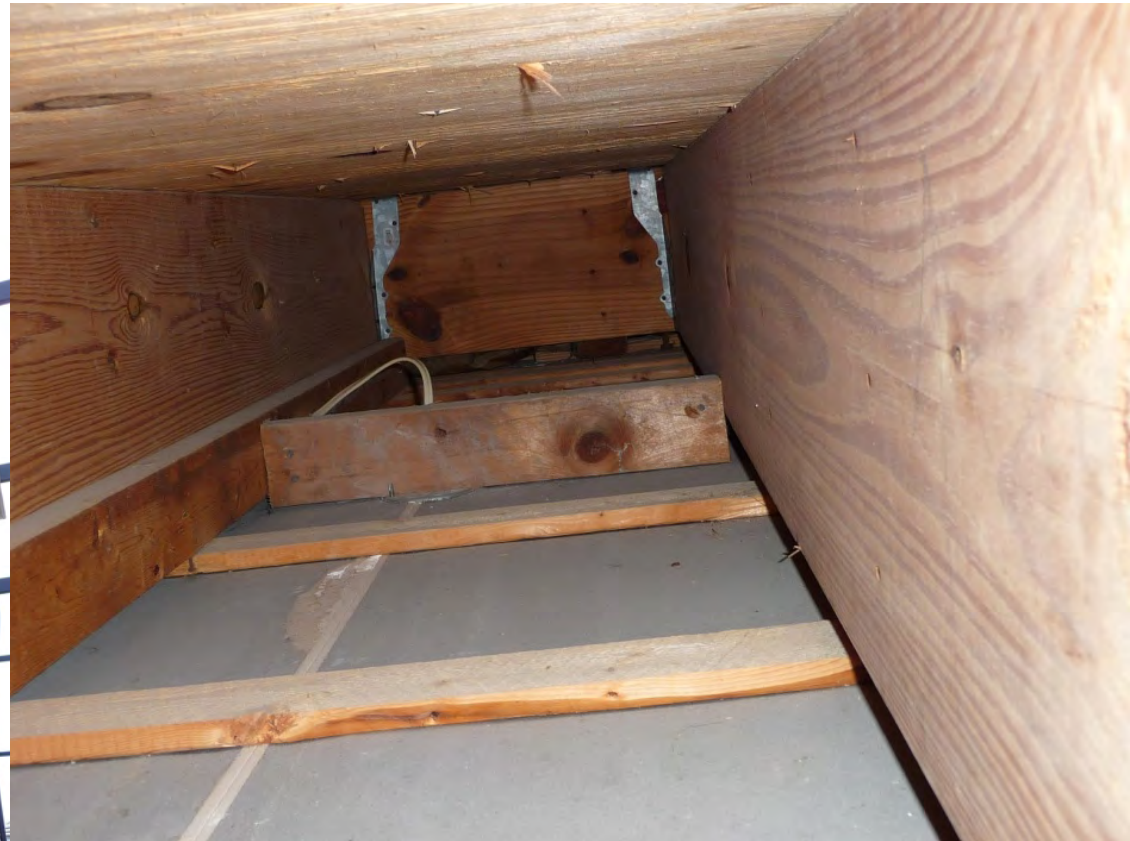
Wind Wash Inspection

Access into west side soffit open to floor space

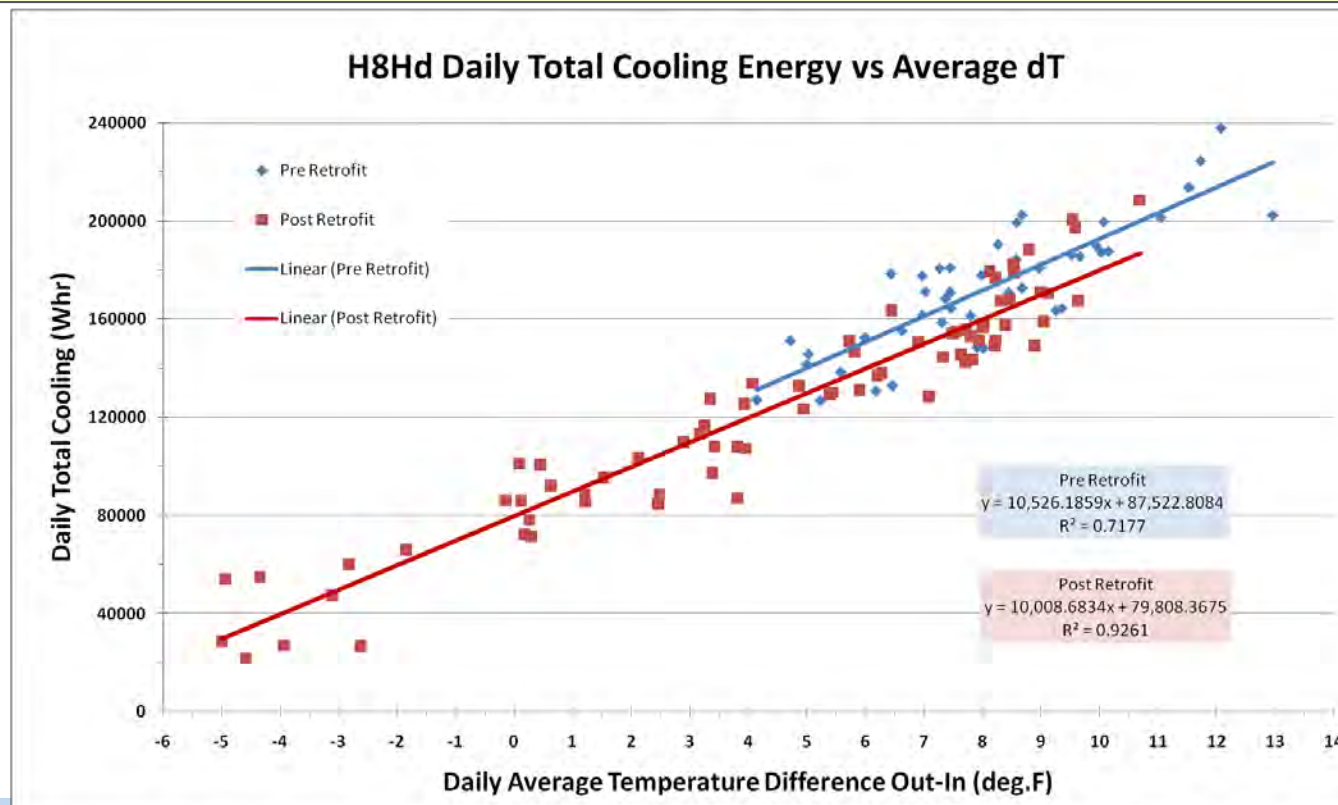
WW Repair Energy Impacts at House 8

- Cooling energy results: 8.2% (est. 2,771 Kwh/yr)
- Peak power reduction 1.8 kW (15%)
- Low cooling setpoint = high cooling energy use

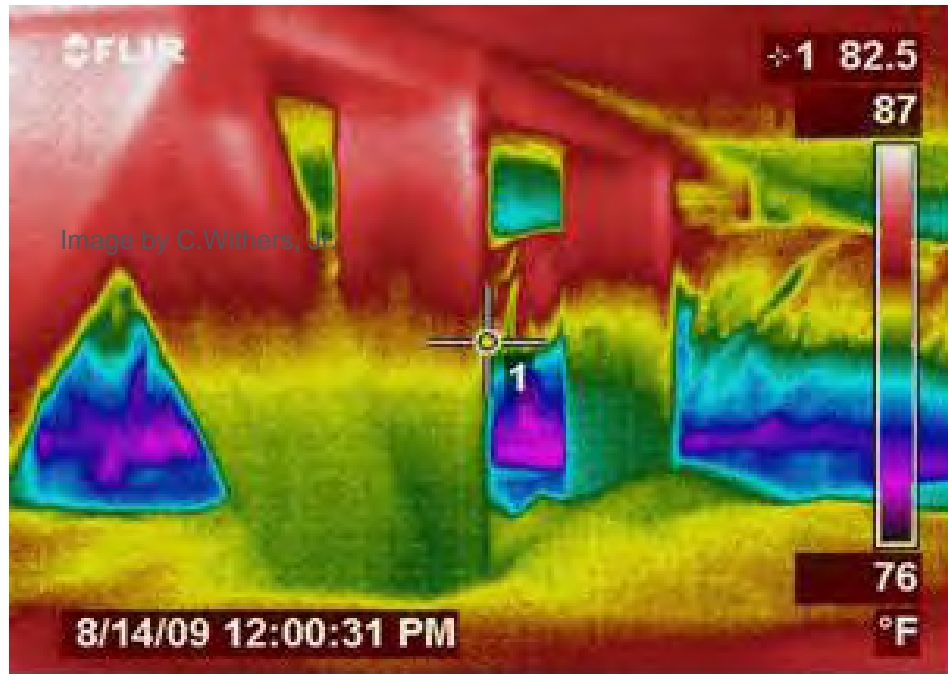
Summary of Impacts from WW Repair

- House tightness- 11.1% tighter (ACH50)
- Infiltration rate (AHUon) decreased 30%
- Return leakage- decreased 37%
- Indicated supply duct leakage decreased 38% (Ppan values 1st floor)

(Based on average of 10 houses that had no direct duct repairs made to them.)
